Infrastructure Projects Southern

Home Safe

The Southern Region's Weekly Safety Update

04 January 2017

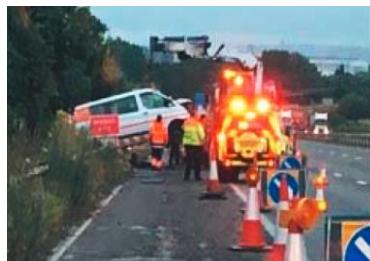
At 04:47 on 29 July 2016, a Ford 9-seater minibus left the north bound carriageway of the M5 and came to rest on the motorway verge. The vehicle was being driven by a sub-contractor working for Network Rail and had three occupants. The team were working for Plymouth Delivery Unit (Works Delivery) and were travelling back to South Wales after a shift near Liskeard, Cornwall. Fortunately, there were no serious injuries.

An investigation has concluded that the immediate cause of the accident was that the driver fell asleep whilst driving. The driver was fatigued due to travelling between the work site and the team's home area near Cardiff. The Contractor had failed to confirm accommodation so the team had nowhere to sleep after their booked shift.

- Everyone should have a minimum of 12 hours rest between shifts. Travelling to a work site counts as work time.
- Travelling time from base to worksite must be considered before allocating work and door to door time must not be planned to exceed 14 hours.
- Planning must take account of fatigue management policies for every shift and identify and confirm designated driver(s). Where necessary, hotel accommodation should also be provided.
- Assurance should test compliance with fatigue management policies.
