# Home Safe

The Southern Region's Weekly Safety Update

07 December 2016

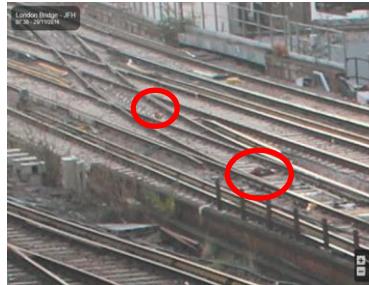
Members of London Bridge P-WAY were installing rail as part of a possession. Two members went to assist with the removal of short circuit straps before the block was given up. The remaining team members removed tools and equipment from site using a trolley to be loaded onto a vehicle at the access point.

A tramm (an on track machine) entered the worksite and came between the trolley and the access. Items such as a disc cutter were left in front of the tramm ready to be placed onto the vehicle once the tramm had exited the site. However, the COSS was not informed that the equipment was still on site and the team left. Only after returning to work for the next shift was the COSS made aware. **You can find a copy of the full bulletin here.**

- Always check that the worksite is clear following the removal of equipment.
- Where safe systems or a method of working changes, a dynamic risk assessment needs to be undertaken to ensure everyone is aware of their duties.
- Timescales should be properly assessed in order to ensure that egress from site and unloading of tools can be undertaken in a controlled manner.

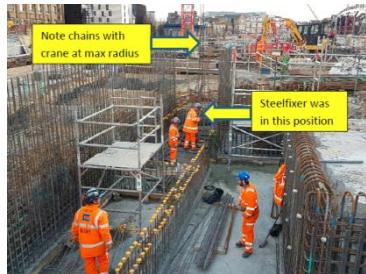
An operative became entangled in a tag line during a lifting operation at London Bridge. The load had been unslung and the crane was hoisting up when the tag line got caught around the operative's ankle. He was lifted approximately 2.5m high before the team became aware of the situation. He was lowered back down and fortunately was not injured.

A steel fixing gang and a slinger-signaller were involved in the activity. A full investigation is currently underway.

- Only trained operatives should be involved in slinging/signalling tasks.
- Slingers/Signallers are responsible for slinging and unslinging loads and should satisfy themselves that it is safe to instruct operators to lift.
- Operatives should make sure that they are clear of loads/tag lines during lifting operations.
- Areas being used to land and store materials should be sufficiently clear to allow safe working.
