Infrastructure Projects Southern Home Safe

The Southern Region's Weekly Safety Update

11 January 2017

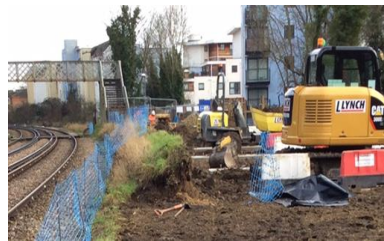
Working adjacent to an open line

An Any Line Open (ALO) plan had been prepared at a worksite at Tovil to use plant adjacent to an open line. However, it was identified that some of the control measures were not appropriate given the changing nature of the site. For example, the earth berm was used as a control measure but was in the process of being removed.

In addition, some of the controls were not being applied, such as the excavator being left with its tracks parallel to the open line. The incident is under investigation.

Always be sure the required plans and permits are in place, before you start a job or go on or near the line.
