IMDM INNER

Potential Near Miss with member of Workforce

On 17th January 2017, at 12:20hrs near Epsom, an Asset Inspector (AI) working for Wimbledon Track on the Number 4 crossing of 840 point Diamonds was involved in a potential Near Miss incident by the driver of SWT 2D27.

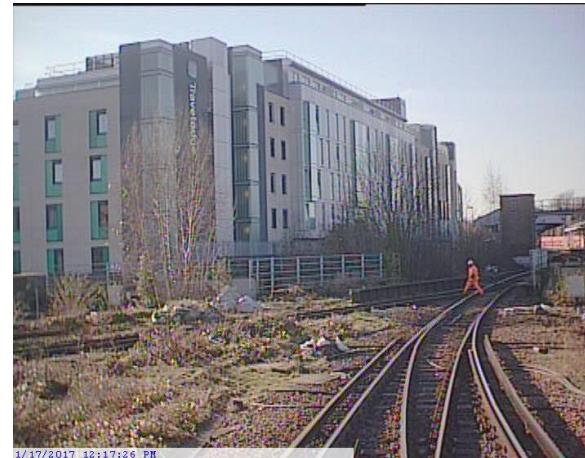
2D27 was travelling on the Down Line at 20mph toward the location of the AI. On seeing him in front of the train the driver sounded the horn twice and engaged the emergency brake.

The AI acknowledged the presence of 2D27 on the first warning and made his way to the Up Victoria (BTH2) line, which he believed to be a place of safety. The train stopped adjacent to the AI.

1. You must have a SSOWP issued for the work you are doing.
2. If you have been allocated a Lookout for protection associated with your work, you must not 'down grade' to IWA without reference to a Responsible Manager.
3. A position of safety for 100mph track or less is a least 1.25m from the nearest line on which a train can approach.
