Infrastructure Projects Southern

The Southern Region's Weekly Safety Update

03 January 2018

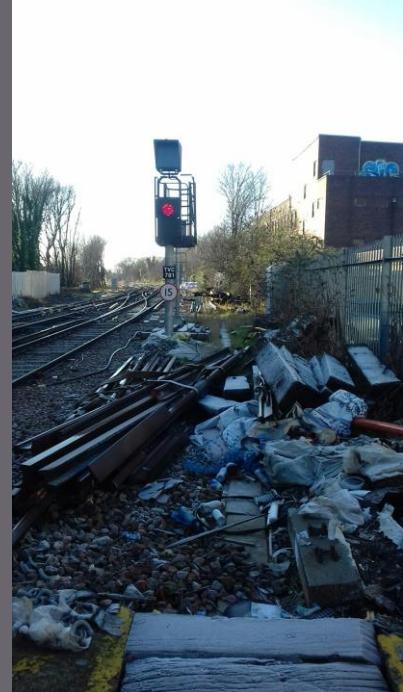
Close Call highlights the dangers on our infrastructure

A recent Close Call raised by one of our contractors at Streatham highlighted the dangers that can be encountered when working on our infrastructure. Although sights such as this can be all too familiar on the railway, it is important that we do not tolerate these hazards and wait until one of our team mates is injured. Always raise a Close Call.

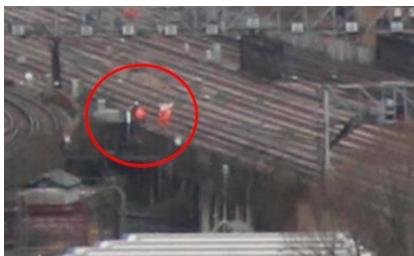
Stepped on a Live Conductor Rail

While carrying out recovery of surplus and redundant materials, a member of a work group stepped onto a live conductor rail on the Down Sussex Slow Line and received an electric shock. He was part of a group that had crossed an open line that they believed to be under possession and isolated,

to reach the access point. However, the access point was outside of the worksite and isolation limits with no safe walking route to it.

An investigation is underway by the Thameslink team. Although it is not suggested that these were factors in this incident, the following is the immediate learning:

- Briefings from the Engineering Supervisor to the COSS should be clear, detailed and concise
- COSSs should familiarise themselves with an area under possession and isolations, especially in multipart possessions
- All COSSs should carry out a Live Line Test witnessed by their workgroup.

Never assume equipment is isolated
— always test before touch.

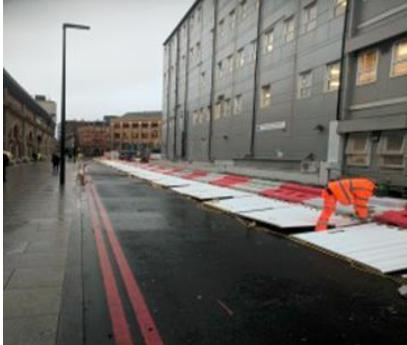
Are your hoardings secure?

Site hoarding separating a public pavement from site offices was blown over during windy conditions. The 68m long x 2.25m high hoarding was a proprietary plastic water-filled Safesite GB2 barrier system. Fortunately there was no one near the hoarding when it fell. An investigation is underway by the Thameslink team to determine the cause but the following points should always be considered:

- Hoardings are temporary works and as such must be subject to design and appropriate design reviews should be undertaken
- Temporary works inspection regimes must be in place
- Any wind speed restrictions must be noted on any designs and form part of the communication to the site teams.

Are your hoardings and fences safe – especially in high winds?
