Home Safe

The Southern Region's Weekly Safety Update

24 January 2018

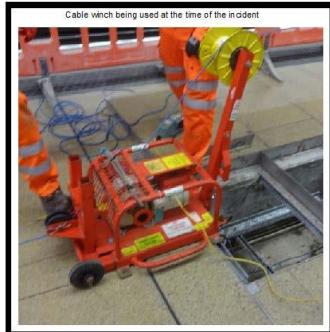
Cable pull causes head injury

At Farringdon station, a cable winch was being used to assist with pulling a cable through a platform invert. A worker had a rope tied around his waist with the other end being fed through the winch. The winch snagged and lifted from its mounting moving forward five metres pulling the worker along the platform. This caused his safety helmet to fall off and he then fell head first down a manhole into the platform invert hitting his head on the frame of the manhole. He sustained a deep cut to his head and injuries to his shoulder and back. The investigation is ongoing.
