# Infrastructure Projects Southern

# Home Safe

The Southern Region's Weekly Safety Update

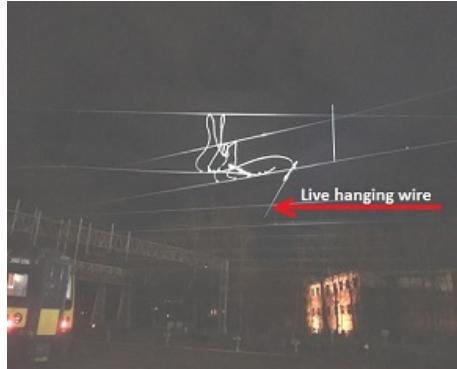
An [overhead line incident](#) occurred near Crewe station when the overhead line contact wire parted as an electric train passed. This caused damage to the train's pantograph and resulted in the contact wire hanging down. When overhead line staff arrived they found that staff had been walking in close proximity to the live contact wire that was hanging down. An emergency switch off had not been requested.

The parted contact wire is believed to have been within 30cm of head height and staff had walked beneath it. In September 2014, a train driver suffered extensive electrical burns in very similar circumstances when they left the cab after the overhead line had been damaged.

**Do you know who should you contact if you believe the overhead line equipment (OLE) may be damaged?**

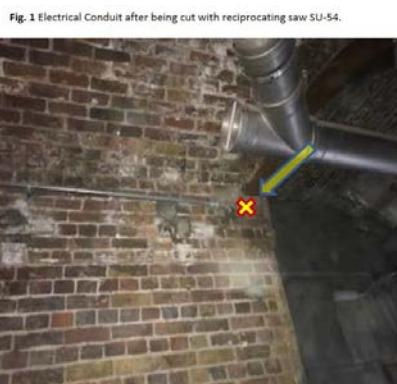
Fig. 1 Electrical Conduit after being cut with reciprocating saw SU-54.

Whilst undertaking 'soft stripping' works, an operative cut through a live conduit using a reciprocating saw. The isolation certificate issued for the works had not taken into account a live conduit which had previously been installed above a false ceiling.

The operative, believing the conduit was part of the soft strip, cut through it in preparation for removal and did not realise he had

cut through a live conduit. It is believed that the main distribution board tripped instantly and the same night the external façade lighting failed to switch on. The investigation is ongoing but do you always consider:

- All known services must be identified on service drawings and made available to those responsible for works
- Anyone providing isolation permits must make sure all services are identified and clearly marked up for removal
- Supervisors must make sure that anyone working around electrical services understands the identification marking for any services to be removed.
