## IMDM OUTER

**Title:** S&T Member of staff working in a location case

**Injury:** Significant electrical shock

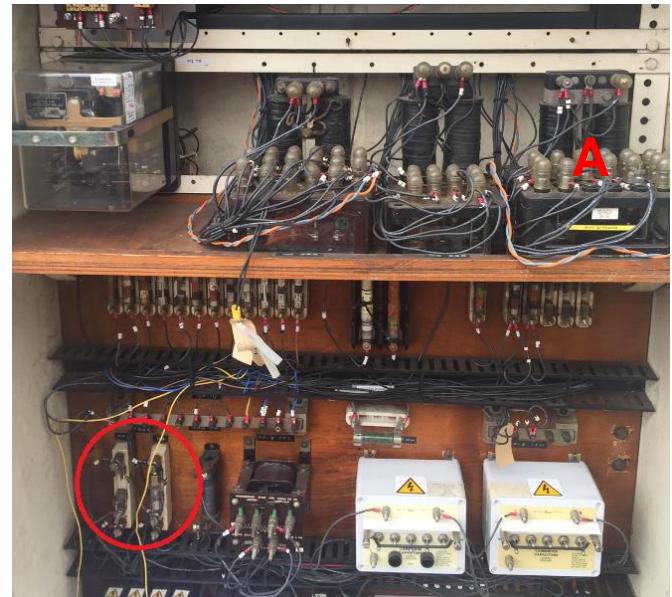
The location case is of metal construction and houses equipment associated with a specific type of circuit; AC 50 HZ double rail track circuits. Located inside this particular type of equipment is a 'Surge Arrestor' component (as identified within the red circle on the photograph), this component was 'live' and exposed; the electrical supply was measured at 575v AC.

During the work activity, the IP inadvertently held the metal location case with one hand and touched the exposed terminal of the surge arrestor with the other, thereby completing an electrical circuit resulting in the electrical shock.

- When working with 'live' equipment it is important to have 'situational awareness'; what are you inadvertently touching?
- Where live terminals exist, consider covering with insulating shrouds similar to the 'OBA' ones shown at A above.
- Use of hand protection; Type 0 (up to 1000v) Insulated gauntlets are available for use. We are trialling Type 00 (up to 500v) to see if this PPE is suitable for activities requiring dexterity.
- Consider what would be your teams' First Aid capability in a similar situation.
