Safety Alert

Significant Accident

Issued to: South East Route
Ref: SMIS2310380
Date of Issue: July 16th, 2018
Location: Dartford
Contact: Emma Foster 07730 359 819

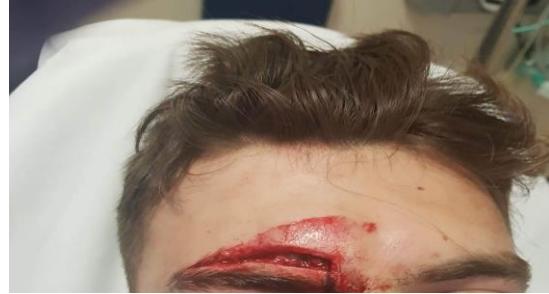
At approximately 1030hrs, upon the approach of a train, the gang were called off and moved to a position of safety. As the train passed the IP was struck by a piece of ballast which broke his safety glasses and resulted in a large laceration above his right eye.

An internal investigation is currently underway, but it is likely that the incident was caused by the train's shoe gear hitting a high ballast profile.

- Please ensure that you have been issued with the correct eye protection for the task and that they are in good condition, and that they are **worn at all times** (if you are unsure **ASK** your Manager)
- Do not hesitate to **challenge** any individual who is not wearing their safety glasses (or full and correct PPE)
- Your **Safe Work Pack** must contain the task, location and operational risks and control measures. Ensure you are briefed on these prior to starting work
- When carrying out similar tasks please be reminded of the importance of maintaining a ballast profile which is **clear of the conductor rail and of the collector shoes**.
- Remember **Take 5 for safety!** Think about the risk before, during and at the end of the task
