## IMDM OUTER

### **Title: Electric shock received from TCR casing live at 750v dc.**

IMDM Outer. Live TCR case at 750v dc  
Issue Date: 21/08/18

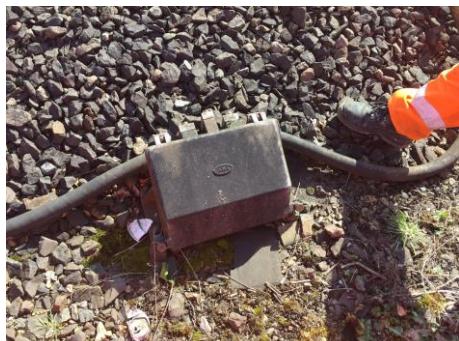
He un-padlocked the case, opened it to carry out maintenance, and whilst maintaining the equipment his right hand came into contact with the casing and he received an electric shock; the casing was found to be 'live at 750v dc'. Work was immediately suspended the equipment was covered and made safe and a warning sign erected.

Figure 1. TCR Ground mounted case (approx. A4 size)

The Work Instruction relating to this equipment will be re-written and issued to the E&P staff by the E&P RAM where the 'Test before touch' LSR will apply.

If there is a need to work in close proximity to a TCR, insulated gauntlets rated 0 will be worn.

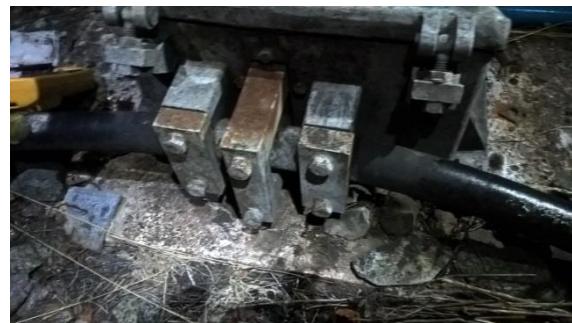
A Temporary Isolation was organised to enable investigations and potential repair. Upon inspection it was found the insulation of the traction cable clamped through the rear of the TCR had broken down, this had caused a hole in the cable which in turn had made contact with the casing making the casing 'live'.

Figure 2. 750v dc cable clamps masking damage.

The cable was replaced with a new cable safely re-clamped the TCR.

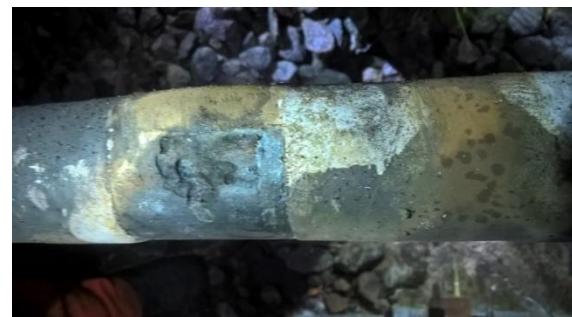
Figure 3. Damage to cable.
