**IMDM INNER****Title: Near Miss at Richmond – 10th February 2019****Incident**

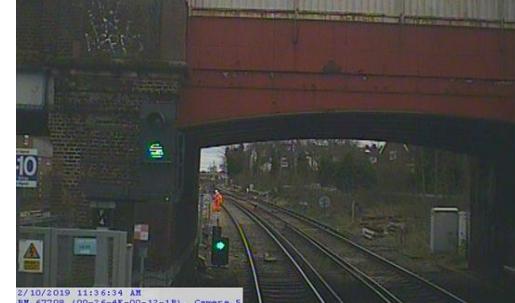
2 staff from Feltham P-way were carrying out a basic visual track inspection (track patrol) between Whitton and North Sheen on the Up and Down Richmond Line (RDG). One member of staff was acting as the PIC/COSS and carrying out the Patrol, whilst his colleague was carrying out the duties of a Site Lookout. After completing the patrol, the PIC/COSS crossed from the Down line to the Up line to walk back toward Richmond Station to maintain 598 points.

The team proceeded 20yds toward Richmond Station, where their sighting distance had been reduced to approximately **175yds**. The minimum sighting distance required to set up a Safe System of Work in this location is **450yds**. The team were about to cross from the Up cess to the Down cess when the Lookout noticed the lights of 5Z07 (an empty coaching stock) approaching through Richmond Station on the Up line and both stepped back out into the Up cess.

As the sighting distance was not sufficient, the team were not in a Position of Safety (POS) for 10seconds before the train passed them, therefore this was a Near Miss.

- **Don't cross the lines if you don't have to!**
- Have you set up, tested and continually maintained your safe system of work?
- Is the safe system of work suitable for the task you are carrying out? Would you challenge it, if not?
- Do the Track Patrols, the associated diagrams and the Safe System of Work used all align?
- Do you check the details within your Safe Work Pack, highlight errors and reject it with comments?
- Is there an alternative access/egress available to you? Would you use it if it's there?
- Have you considered any unusual train running patterns? (on the day in question, SWR were running extra trains between Waterloo and Twickenham for the rugby).
- Do you **'take 5'** before, during and after the work?
