Transferable Lessons from Serious Operational Incidents / Investigations

NR/OPS/047

Member of public trapped at Maxey CCTV Crossing

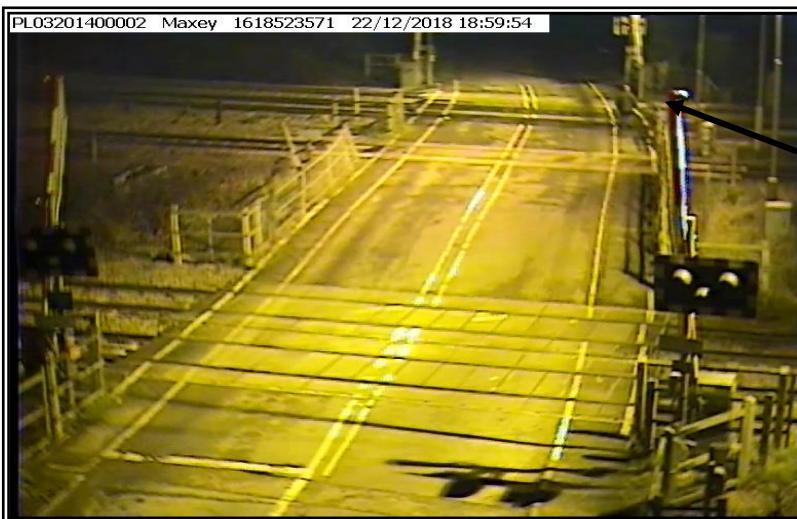
Member of Public.
(Walking towards the top of the screen).

On Saturday 22nd December a member of public became trapped within the confines of Maxey CCTV crossing. The individual stopped in the top right corner of the LC when the lowering sequence was initiated, which was not identified by the Signaller. Two trains passed over the crossing before the trapped person was released.

1. Observe the crossing to ensure that it's safe to begin the lowering sequence (for auto lowering sequence skip to step 3).
2. When Safe to do so, press **LOWER** to begin the lowering sequence. **Observe** the lowering sequence where instructed locally.
3. When the lowering sequence is complete, **CHECK** the crossing is clear using the **FIGURE OF 8** scanning technique
4. If in doubt **CHECK AGAIN**, ask another person to assist or raise the barriers and return to step 1.
5. If the crossing is **OBSTRUCTED**, you must **RAISE** the barriers and return to step 1.
6. If the crossing is **CLEAR** press **CROSSING CLEAR**.

Always **5** before pressing Crossing Clear.

Report and Close Call any poor-quality CCTV cameras
