## IMDM OUTER

Staff Accident: Twisted Ankle using Access Steps  
Injury: Tissue Damage to Right Ankle

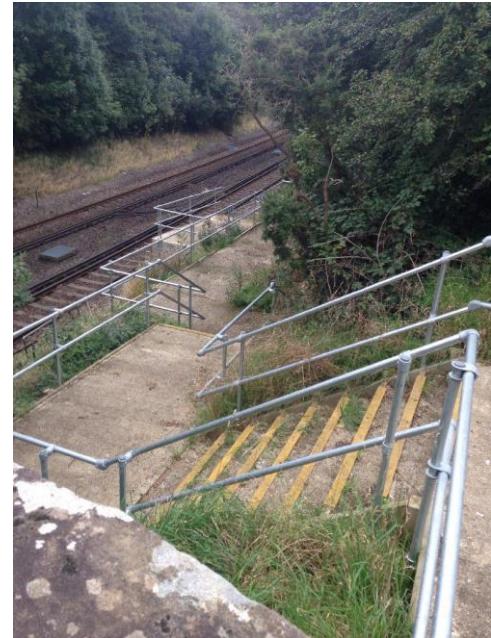
On Thursday the 11th March, in preparation for the work, a L OSC was carrying a stressing ram down a set of steps to the track at Vaggs Lane access point on the BML2.

On reaching the last step of the last tier the IP turned his ankle which resulted in a sprain and tissue damage.

The access point consists of 3 flights of stairs with landing points, which were lit by temporary lighting.

- Mechanical means should be used to transport equipment to site whenever possible
- Suitability of access points should be considered at planning stage
- Be aware of your limits and seek assistance if required
- **ENSURE the correct safety footwear is being worn.**

The Network Rail PPE standard NR/L2/OHS/021 states: **Rigger boots do not meet the requirements for ankle protection and shall not be used.**
