## IMDM INNER

Title: Stressing Kit fluid injury: IP sprayed in face with hydraulic fluid.

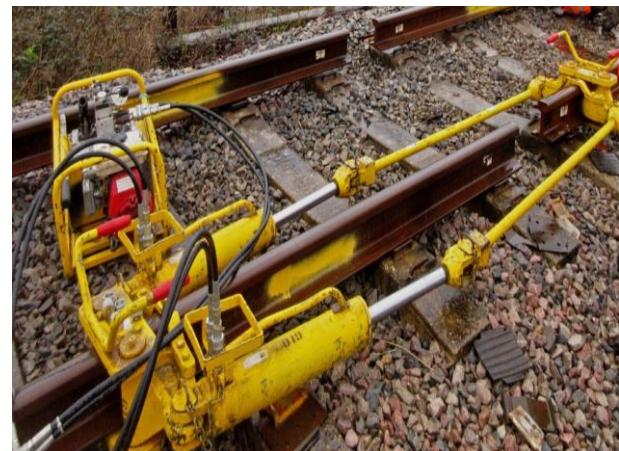
On the 18<sup>th</sup> of May 2018 at 14:25 hrs at Woking Junction up sidings, a Network Rail Team Leader was sprayed on the side of the face by excess hydraulic fluid from a stressing kit ram. The IP was attending to a broken Insulated Block Joint (IBJ); the work involved the use of a stressing kit to prevent movement of the rail.

Following the replacement of the IBJ, the stressing kit had hydraulic pressure released prior to the stressing ram pipes being removed. The IP was standing next to the equipment as the pipes were taken off; he had just removed his safety glasses because they had steamed up due to both the hot weather and the work that he had been involved in.

Another member of the team removed the pipe from the ram and a small amount of excess fluid contained within the pipe flicked up and sprayed the Team Leader on the side of the face close to his left eye.

1. After use of the stressing Kit make sure the power pack is stopped, pressure released and hoses purged before connecting or disconnecting the puller unit.
2. Warn and clear the area of other people in the vicinity of the activity.
3. Safety glasses must be worn at all times. If glasses need to be removed to be cleaned, first move away from any work which is taking place
4. Make sure a first aid kit is always on site and eye wash facilities are included.
