Health, Safety and Environment Period Cascade for P01 2019/20

Wessex Route

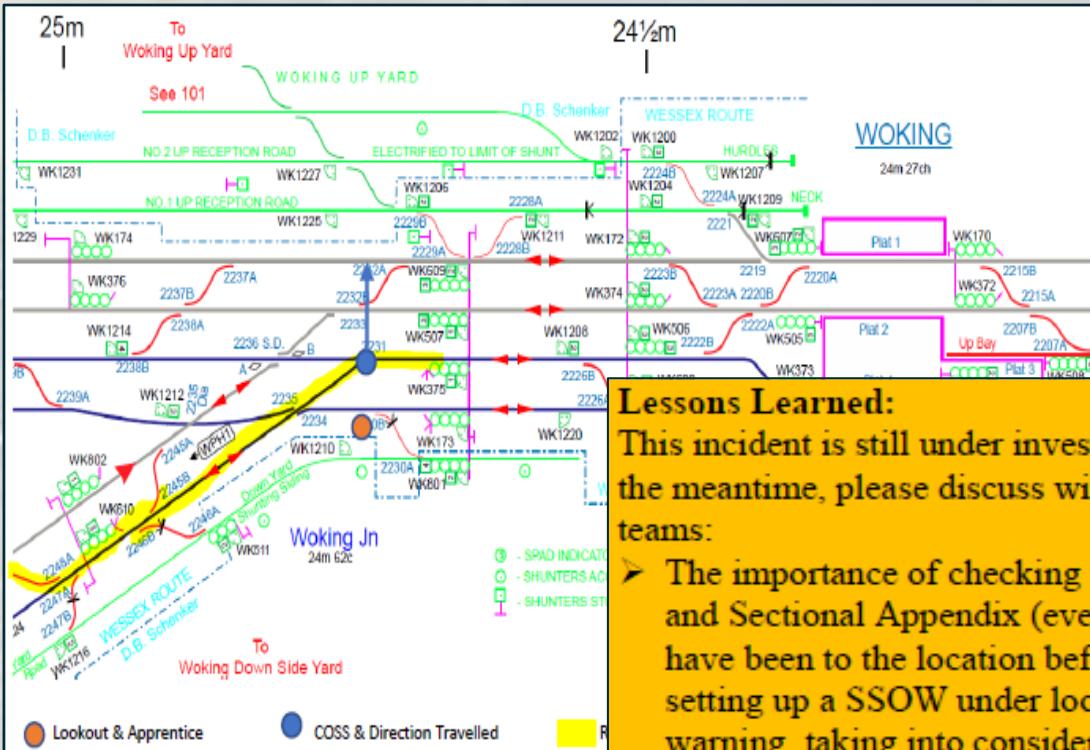
Near Miss at Woking Jn

On 15th April 2019 at 11:27, during a Track Patrol of Woking Junction on the Down Fast of BLM1 at Country End of Woking Station, the Patroller /COSS was involved in a **Near Miss** with a SWR train 1P32.

This was a regular patrol and involved an experienced patroller. He had situated his lookout in a regularly used position of safety in the down cess, whilst he inspected 2231 pts. The site lookout was instructed to look out for trains moving toward the group on the Down Main and Slow. The 1P32 approached the group on the bi-directional Down Guilford line having crossed from the Up Guilford line (London bound).

The lookout noticed movement of the 1P32 toward the Patroller/COSS who made his way across the Down Main, Up Main and Up Slow to a position of safety. The 1P32 passed this location approx. 4 seconds later.

Lessons Learned:

This incident is still under investigation. In the meantime, please discuss with your teams:

- The importance of checking the SWP and Sectional Appendix (even if you have been to the location before) when setting up a SSOW under lookout warning, taking into consideration all lines where the movement of trains into the site of work can occur.
- The importance of Lookout/s having clear instruction regarding which lines and direction of travel they are looking out for.
- Tell the lookout where you want him to look and make sure sufficient sighting distance can be achieved in all directions.
- If you believe something is not safe, CHALLENGE!

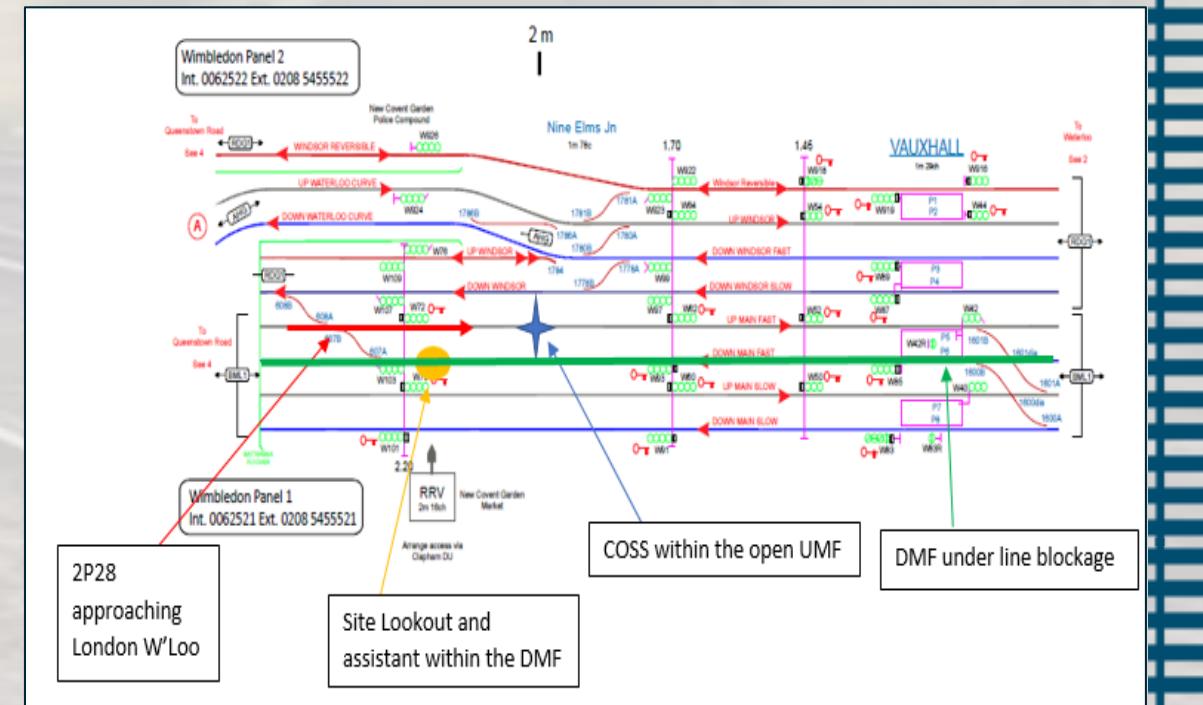
Near Miss New Covent Garden Market – Period 02

On the 28th April 2019, a 3-man maintenance team based at Clapham Junction were undertaking a track inspection of the Down and Up Main Fast lines of the BML1's between 1m78ch and 2m50ch. The work was to be carried out within a Protection Controller's line blockage of the DMF.

The UMF was to be inspected under Lookout protection, using the blocked DMF as the position of safety.

The COSS/PIC instructed the Lookout and the assistant to remain at 2m14ch while he walked toward London to carry out the track inspection as far as 1m78ch.

After the COSS/PIC had completed this inspection he began to walk back toward his group on the DMF when he identified a number of dislodged Pandrol clips on the UMF.

The COSS/PIC crossed into the UMF to replace the clips and whilst undertaking this task 2P28 (Portsmouth to Waterloo) approached. The COSS did not hear the first warning from the driver. After the second warning the COSS acknowledged the driver and stepped into the POS in the blocked DMF.

Both the Near Misses are currently under investigation but the initial findings highlight the following:

- **Importance of the decisions we make every day**
- **Importance of raising concerns if something does not feel safe**
- **Importance of challenging each other to ensure we all go home safe to our loved ones every day**

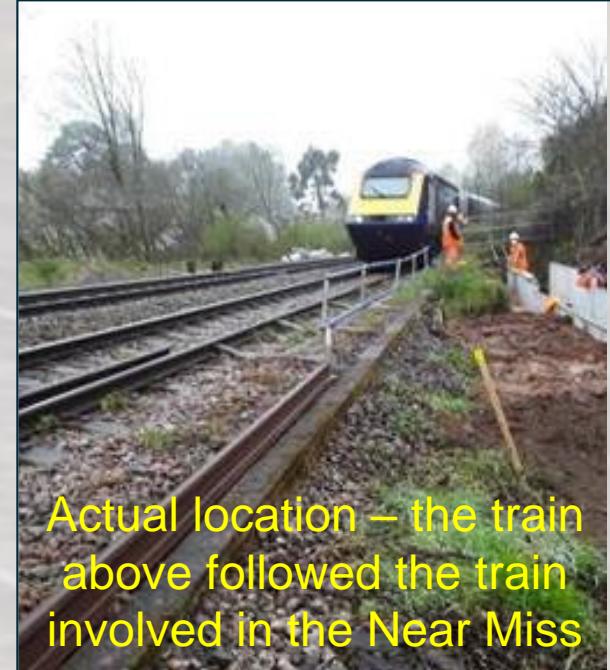
On the 16th April 2019 a train passed a work group after the COSS took an approved line block with the Signaller.

The Driver did not sound the horn or report this as a Near Miss, as the 8 tonne excavator, which was being used to lift concrete blocks, was 8 meters away from the line and the 4 men team was in the cess side of the vortok fencing (separated). However this was an ALO work and the line was believed to be blocked, so the consequences could have been catastrophic. The COSS is currently receiving counselling as he keeps replaying the incident and he has also been taken off of safety critical duties. The voice communications were reviewed and the COSS made no Safety Critical Communication errors.

Actual location – the train above followed the train involved in the Near Miss

Please discuss with your teams:

- The importance of ensuring good Safety Critical Communications are followed at all times. Repeat back any signaller instructions and make sure a clear understanding is reached
- GERT800-HB8 Issue 7, IWA, COSS or PC blocking the line – Additional Protection should be used where possible

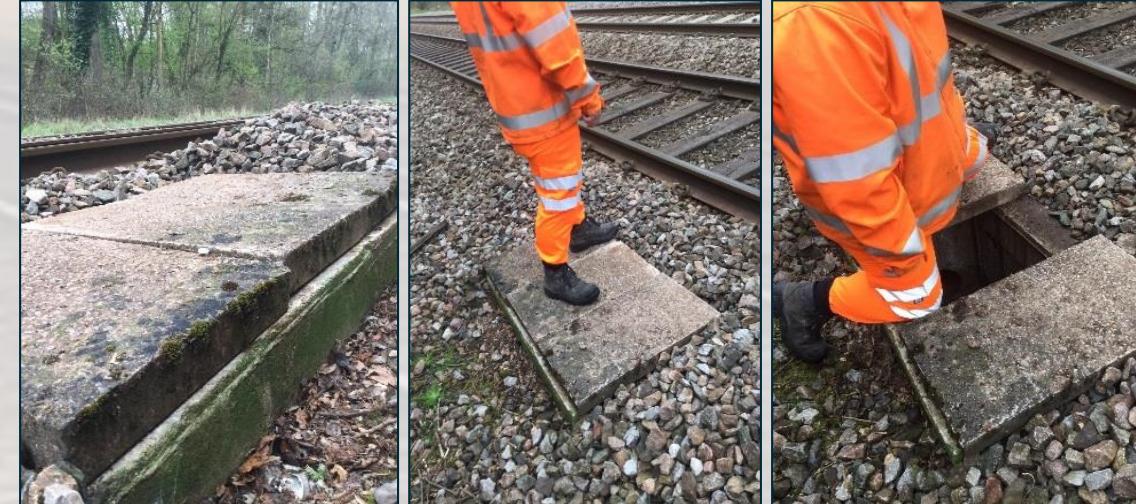
Significant Lost Time Injury – dislocated knee

On the 4th April 2019 at approx. 12:02, an Off-Track team member based at Eastleigh, was working at Dunbridge (on the RTJ2) as part of the team clearing ballast from the tops of catch pits to enable future inspections.

After clearing ballast of the final catch pit, the team were ready to move over to the Up Road where the walking route was more suitable.

The IP, who was acting as a lookout, stepped onto the centre of a concrete catch pit lid which gave way underneath his right leg. This caused the IP's left knee to come down on the catch pit lid to the left of him and resulted in a knee dislocation. The IP has not been able to return to work to date.

Lessons Learnt

- Awareness of underfoot conditions
- Avoid stepping/standing on catch pit lids as they could be unstable
- Report any unsafe underfoot conditions via close call system and mark them up if possible to warn others

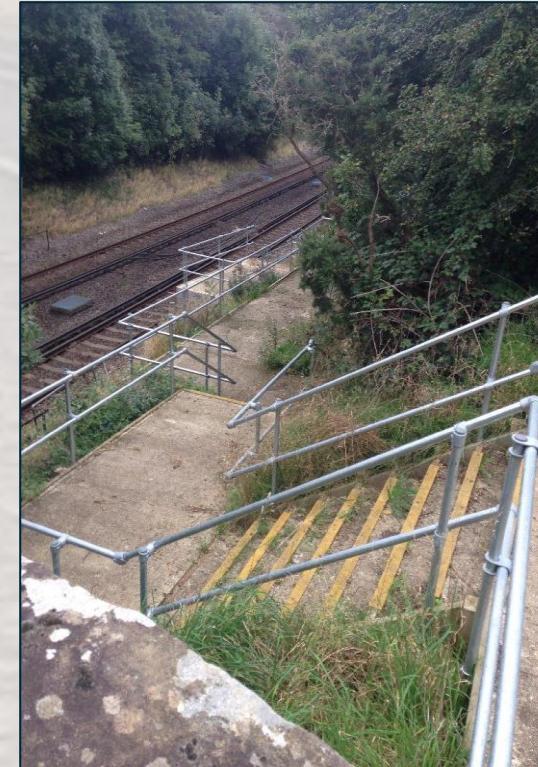
Lost Time Injury - Tissue Damage

On Thursday the 11th March, in preparation for the work, a LOSC was carrying a stressing ram down a set of steps to the track at Vaggs Lane access point on the BML2.

On reaching the last step of the last tier the IP turned his ankle which resulted in a sprain and tissue damage.

The access point consists of 3 flights of stairs with landing points, which were lit by temporary lighting.

The individual was wearing a pair of "Rigger boots" and acknowledged he was aware this type of boots does not offer Metatarsal protection and ankle support.

The Network Rail PPE standard NR/L2/OHS/021 states: **Rigger boots do not meet the requirements for ankle protection and shall not be used.**

Boa style boots are now available on I-proc and can be ordered for your staff. These boots come with fitted metatarsal protection and some of the other benefits are:

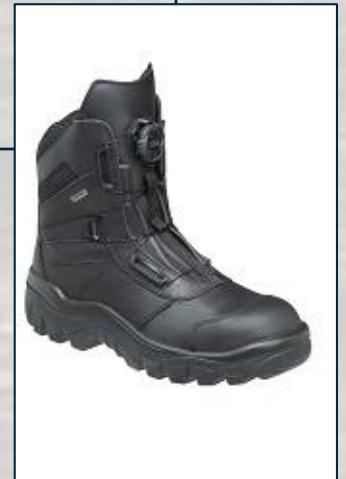
Supplier Item NR10/5

- No laces to trip over
- Time saved putting on and taking off the boot
- Even tightening
- Quick release if the boot gets stuck

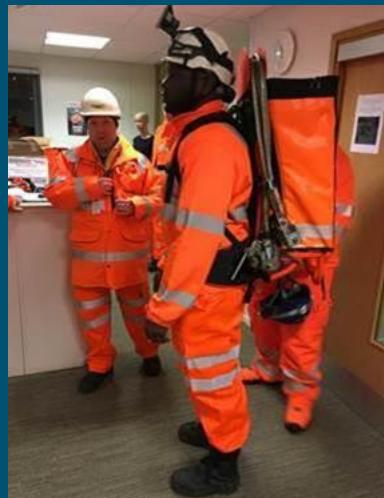
Did you know that a specialised backpack has been developed (with the assistance from our route) to assist the strapping teams to carry all the necessary equipment to site safely. It is designed to carry 2 shorting cables, 2 worksite marker boards (lightweight version) and all the PPE, testing kit and paperwork for the task.

The backpack has a yoke to carry the shorting cables (preventing the need to carry them over the shoulder or roll them up in the bag). The bag is attached to the frame by magnets, so can be pre-loaded and stored away from the frame. Also, if the bag is snagged, it pulls off the frame to protect the user. The harness includes waist and chest straps to spread the load on the spine.

The backpack is available through iStore reference 0111/120776

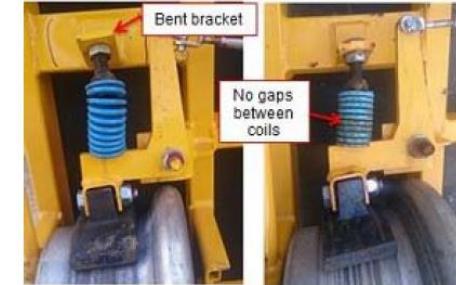
Safety critical failures of link trolley brakes - Issue 2

Inspection of the link trolley fleet at Northampton Bridge Street Depot during 2015 found three out of eight units to have brake systems that had failed. Further investigation with Torrent Trackside identified evidence of other trolleys returned for maintenance with similar failures.

The right-angled bracket, which is welded to the frame and holds the brake spring in place, was bent away from the wheel. This reduces the brake force and increases the risk of runaway.

Gradient restrictions have been imposed on ironmen and link trolleys due to these incidents of a maximum gradient of 1 in 150.

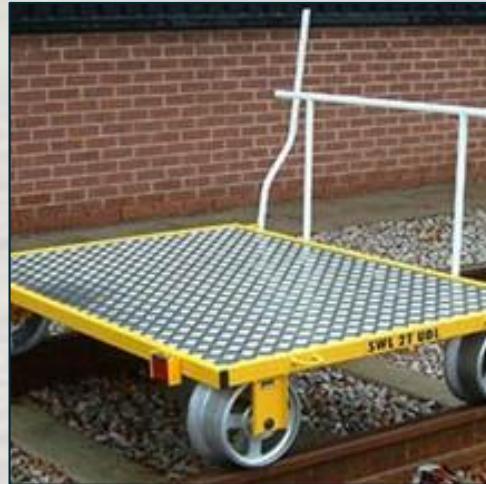
Type A trolley is a single platform trolley that weighs 90kg and can carry a UDL of 1000kg. Can be used in gradients up to a maximum of **1 in 50** as per Handbook 10 GERT8000-HB10.

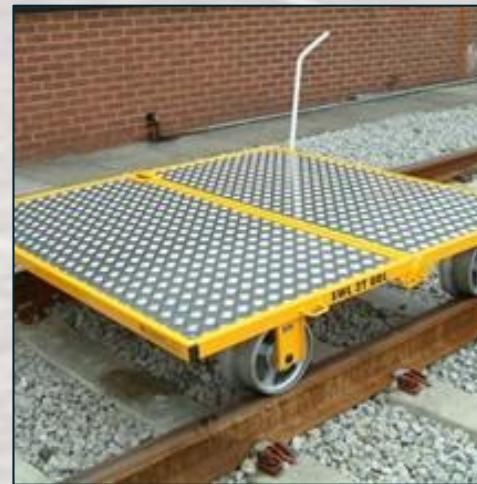
Type B trolley is in 2 parts and weighs 130kg. This has a larger loading platform than the type A trolley and can carry a UDL of 1000kg. This trolley can be used in gradients up to a maximum of **1 in 50** as per Handbook 10 GERT8000-HB10.

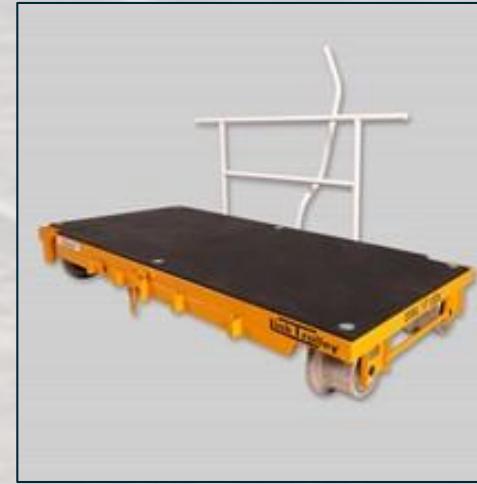
Link type trolley has a smaller loading area and weighs 47kg. Each link trolley can carry a UDL of 1000kg. Three link trolleys can be joined together, which can carry a UDL of 2000kg. This trolley can be used in gradients up to a maximum of **1 in 150**.

The gradient restriction of **1 in 150** applies to link type trolleys and manually propelled rails handlers (ironmen).

If you are planning to work in an area with a gradient greater than 1 in 100, then **control measures must be put in place to reduce the risk of runaways as per the standard NR/L2/OHS/019**.
