Health, Safety and Environment Period Cascade for P02 2019/20

Welcome to your Health, Safety and Environmental Cascade for Period 02 2019/20. Please discuss and share the items that are relevant to your teams and display any relevant Safety Bulletins or Lessons Learnt on your notice boards.

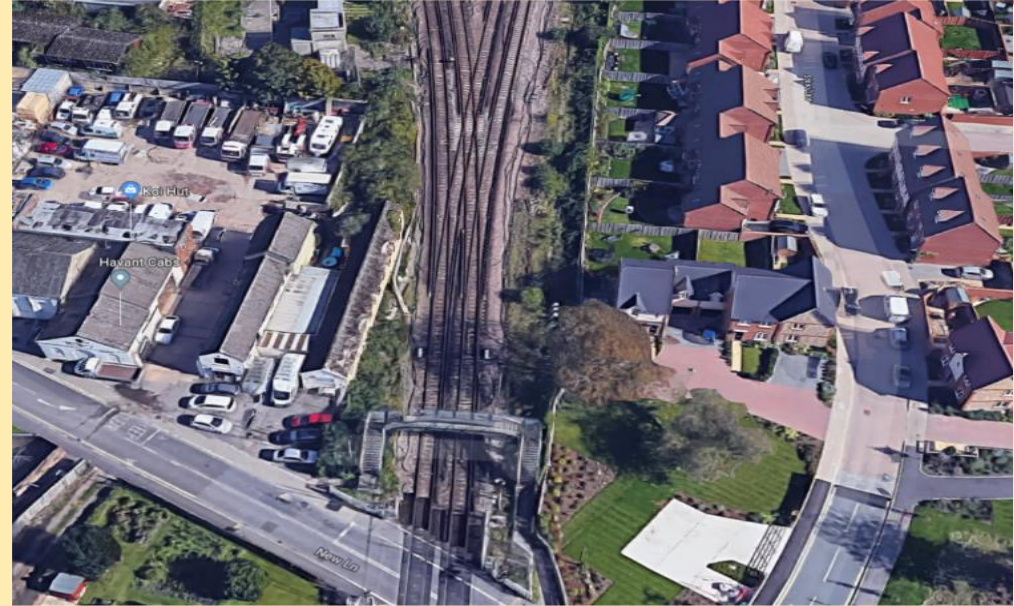
Near Miss at Havant Junction

On Saturday the 25th of May at 04:59 a near miss occurred at Havant Junction between an Engineering Supervisor and an empty passenger train.

The ES strayed outside of the worksite and possession limits, to watch a Rail Grinder out of his work site. At the same time he began to make phone calls to his teams to prepare for lifting the worksite protection. As he was doing so he heard a horn being sounded and moved into the 4 foot of the adjacent road.

As the horn continued to sound he turned around and saw a train coming along the "Open Line" that he had stepped into. The ES then immediately moved into the CESS to avoid contact with the train.

- The importance of always being in a position of safety whilst using your mobile phone
- The importance of staying within the limits of your safe system of work
- The importance of remaining vigilant whilst walking trackside and not allow distractions.

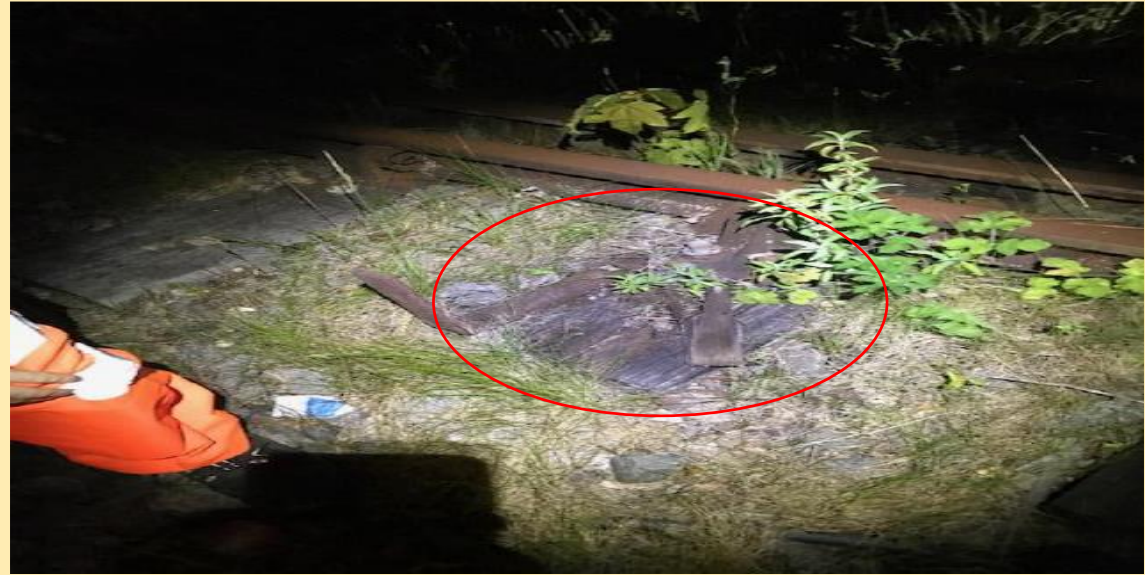
Staff Injury- Muscle Sprain Under Arm and Right Side of Chest

On Friday the 24th of May a member of staff injured himself whilst walking in the CESS of the Aldershot down side, old siding, country end of Aldershot station on the PAA1 at 35m00ch. The IP was making his way along the CESS when his foot got caught on an old rusty metal L bracket attached to a sleeper.

The IP tripped and twisted his body, falling and landing heavy onto right shoulder on the ballast.

The individual was at the front of a work group, who were wearing head torches as there means of lighting and were carrying out routine maintenance.

- Did you leave your worksite in a safe condition for others?
- Did you report potential hazardous obstructions or others similar?
- If so, did you follow up why it was not removed?
- If you were unable to remove the hazard did you clearly mark it up to prevent other from walking into it.
- Have you been provided with suitable lighting for your intended work?

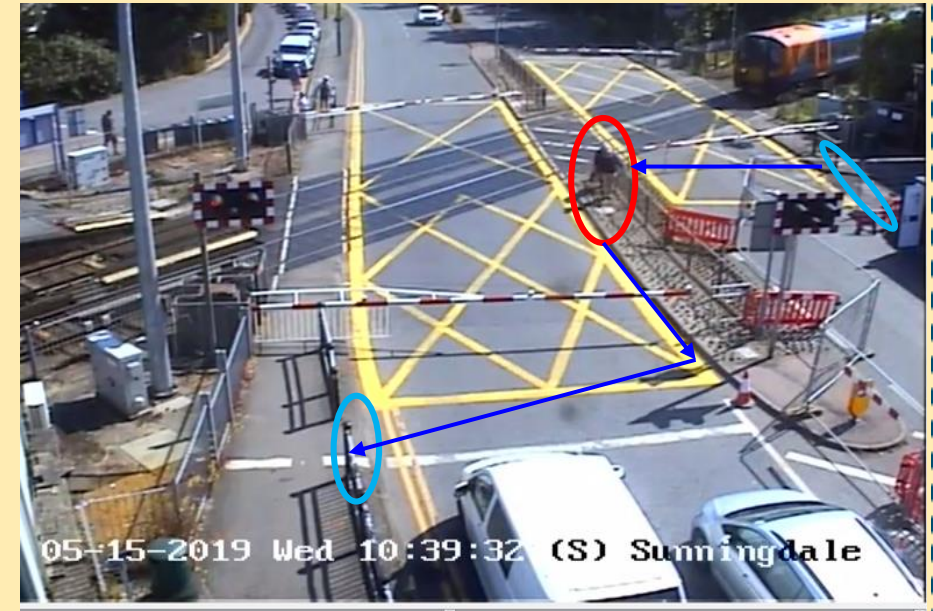
Near Miss Sunningdale LC

On the 15th of May, there was a near miss at Sunningdale level crossing(LC) where two members of the public (MOP) crossed the road via the LC barriers, moments before a train passed through.

Contractors undertaking water pipe replacement works on behalf of a water company, closed off a section of the southbound lane and pedestrian crossing on the A30 London road near Sunningdale LC. A temporary pedestrian crossing was put in place and located at approximately 60 meters away from the normal crossing point, to allow MOP to safely access shops, restaurants located on the southside of the road.

At 10:39 am after the LC barrier had been lowered, two MOP crossed the road via the barrier from the southside pedestrian walkway, moments before a train passed through.

Following the incident, an inspection of the worksite showed that the contractor had not secured the point from where the MOP accessed the LC. Advance warning signs were not adequate and had not been positioned at appropriate locations.

Additional controls in the form of signages, heras fencing and 24 hrs road traffic marshals were put in place. This however proved inadequate, as further incidents were witnessed during inspection.

To ensure the safety of the public and operational railway, a decision was made to close the southside pedestrian walkway for the duration of the works.

- Are initial planning processes for worksites operating near the rail infrastructure, robust enough
- The importance of reporting unsafe working practices and conditions near the rail infrastructure to the WICC or via the close call process
- The importance of regular monitoring of worksite locations for changing conditions that might affect the safety of the public and operational railway

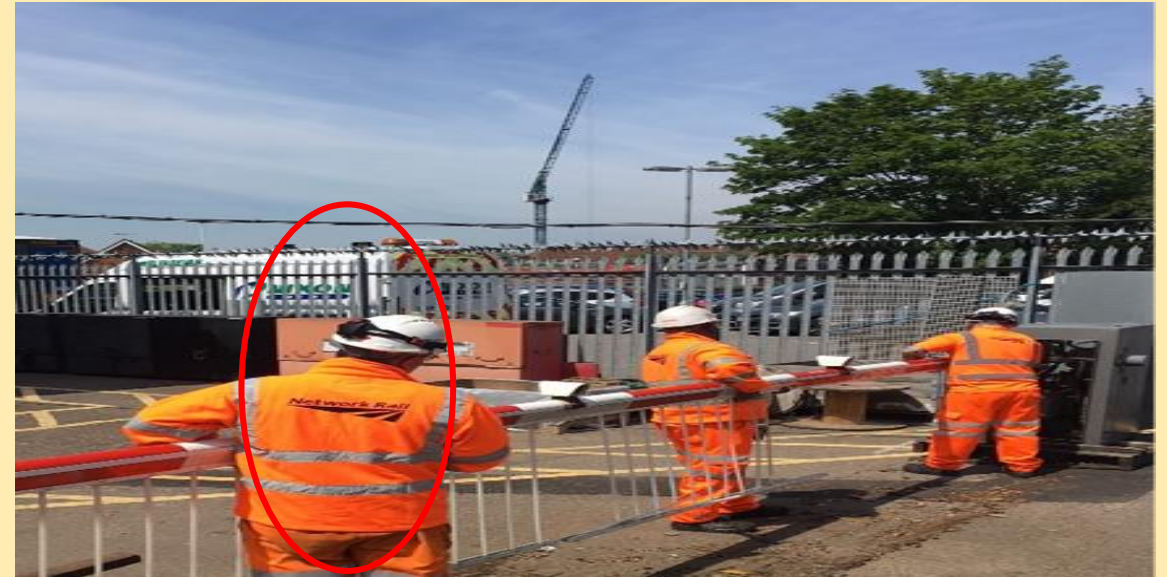
Lower Back Strain Feltham S&T

On the 14th of May, a 3 person team from Feltham Signals and Telecommunications (S&T) (made up of the NR injured person, a PIC and a Contract member of staff) were replacing a 6 metre level crossing barrier boom into the ZO pedestal at Grove Park level crossing.

As the barrier boom was being replaced, the IP(circled) felt a pain in their lower back but continued to work and did not report it until they returned to the depot at approximately 03:40. By this time their back had begun to stiffen up.

As part of the initial investigation it was discovered that the level crossing barrier boom does not denote the weight, either on the boom itself or on the product information supplied with the boom.

It was subsequently found that the weight of this particular level crossing boom (6 metre long) is 90KG.

- **THINK; Do you know the weight of the equipment to be manually handled? Is the weight displayed on the equipment?**
- **Do you have the resources to carry out the required work?**
- **Check your posture, can you do something, even when sitting, that will make your back healthier?**
- **Avoid twisting and keep the load close to your body.**
- **Know your limits!**
- **See the 'Healthy Back' presentation or the 'Think Risk' film on Safety Central for some helpful tips.**

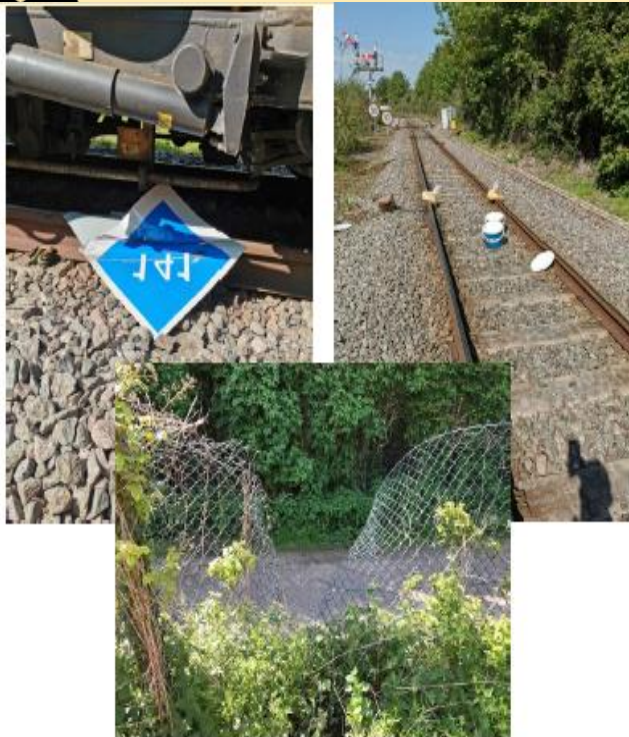
Malicious Act — items placed on the line

On Sunday 12th May 2019 at approx. 08:31 the BTP received a report from the local police that there were obstructions on the Single line between Yeovil Pen Mill Station and Castle Cary ((WEY) at 141m00ch. The first train through this location was cautioned, but struck the mile post sign that was laid across the line and came across some grease buckets and sand bags placed on the rails. It was discovered that the perpetrators gained access to the line by cutting the chain link fence at approx. 141m05ch.

Fortunately on this occasion no one was harmed. However, the obstructions were intended to disrupt rail operations and this incident may have had very different outcome. Placing objects on the line has clear safety consequences for rail passengers, train crews, our colleagues attending such incidents and to the individuals committing the criminal and malicious act.

- We are all responsible for maintaining the safety and security of the railway. Access points, equipment and materials must be properly secured during works with lineside scrap and unused materials removed on completion. Guidance can be found in Task Risk Control sheet NR/L3/MTC/RCS0216/GA25.
- Malicious obstructions, unusual objects or obvious signs of trespass (damaged fences well-trodden paths, criminal damage etc.) must be reported. Colleagues should be alert and look for unusual activity or behaviour.
- Challenge anyone on or around the railway who you believe should not be there and report such incidents to BTP and route control. If you believe you may be in danger maintain a safe distance or leave the area and call the Police.
- Apply the HOT and WHAT protocols.

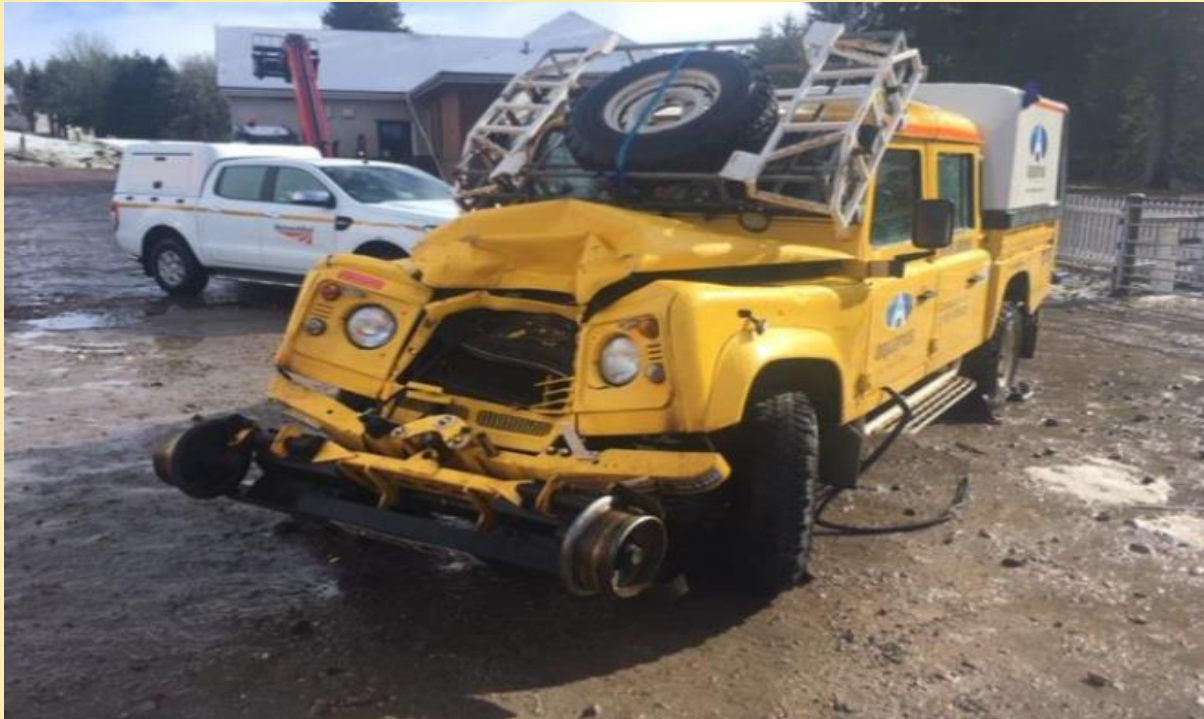
Damage resulting from collision between 2x OTP in Scotland in March 2019.

All movements are to be made at a speed up to 5 mph unless authorised by an ES to travel at caution, up to a maximum of 25 mph.

There must always be an authorised method statement when on track plant is operated on Network Rail managed infrastructure.
