Health, Safety and Environment Period Cascade for P04 2019/20
Wessex Route

Welcome to your Health, Safety and Environmental Cascade for Period 04 2019/20. Please discuss and share the items that are relevant to your teams and display any relevant Safety Bulletins or Lessons Learnt on your notice boards.

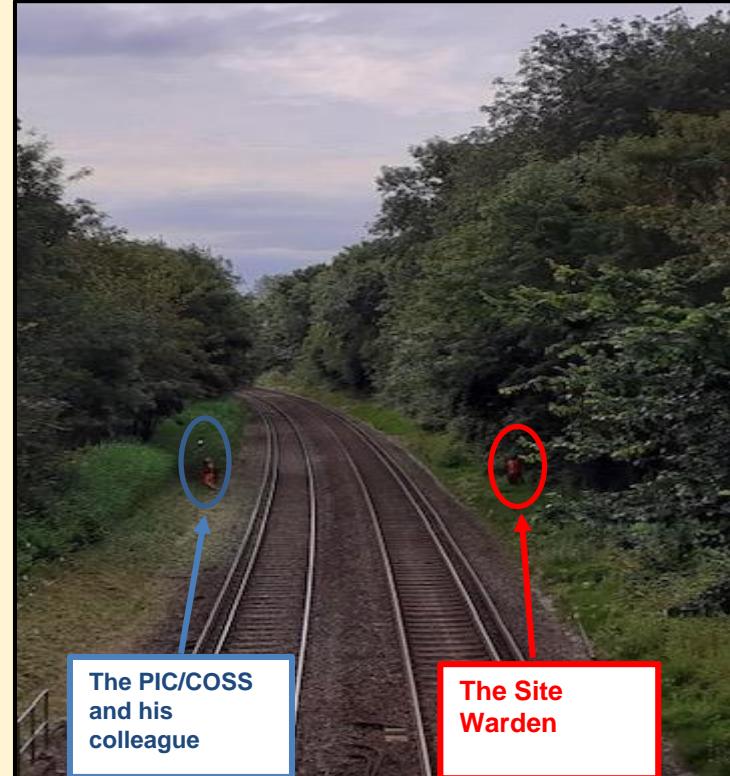
On the 10th July 2019 a 3 man Nash team were working on behalf of the Inner Off Track team in the Earley area on the RDG2 at 66m48ch. Another member of NR observed the team and was concerned that the SSOW was not adequate.

The PIC/COSS set up a SSOW under protection (Green Zone) whilst carrying out brush cutting in the Up Cess. This particular type of work **must only** be carried out under protection arrangements. Due to the nature of the task the PIC/COSS and the other member of the team were wearing ear defenders.

The PIC/COSS positioned a Site Warden across the two lines in the Down Cess.

As a result the Site Warden was unable to adequately provide a warning should the team members have encroached closer than 2 metres (6'6") towards the open line.

It also meant that the PIC/COSS had no control or visibility over the movements of the Site Warden should he have chosen to leave his position.

- Are your **safe systems of work suitable, implemented correctly and then tested prior to work starting?**
- **Where should a site warden be situated?**

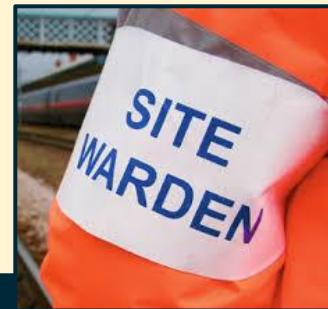
What is the purpose of a Site Warden?

- **Where there is a distance of at least 2 metres (6 feet 6 inches) between the nearest running rail of an open line and the site of work, a site warden will be appointed.**

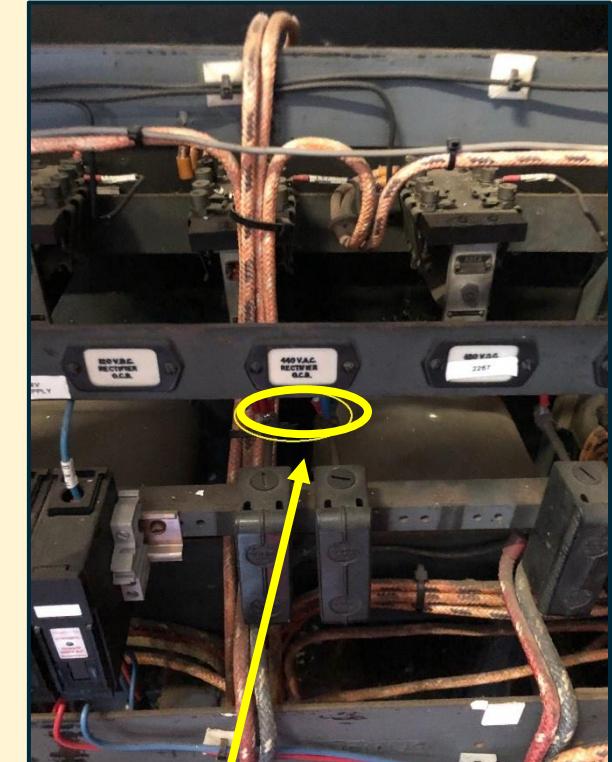
Whilst investigating a suspected rectifier fault at Brookwood Substation, on Monday 15th July 2019, the IP came into contact with the exposed live 435v terminals.

The preliminary investigation established that due to the age of the equipment it was not possible to isolate the whole panel, so live equipment sources were still present.

No gloves were worn at the time as neither the Class 0 or Class 00 electrician's gauntlets provide the required dexterity.

The only sign of injury were 2 small burns on the base of his thumb.

The exposed live terminals

- Where 'Live' exposed electrical equipment is present, what can you do to protect yourselves? (Think RISK!)
- Can a protective matting be used to remove the risk of accidental contact?
- How can you highlight the potential risks to your colleagues?
- Where any contact with 'Live' electrical equipment takes place, DON'T CHANCE IT, GET CHECKED. Visit your local hospital or A&E.
- This incident took place AFTER the task had been completed, think RISK at all times.

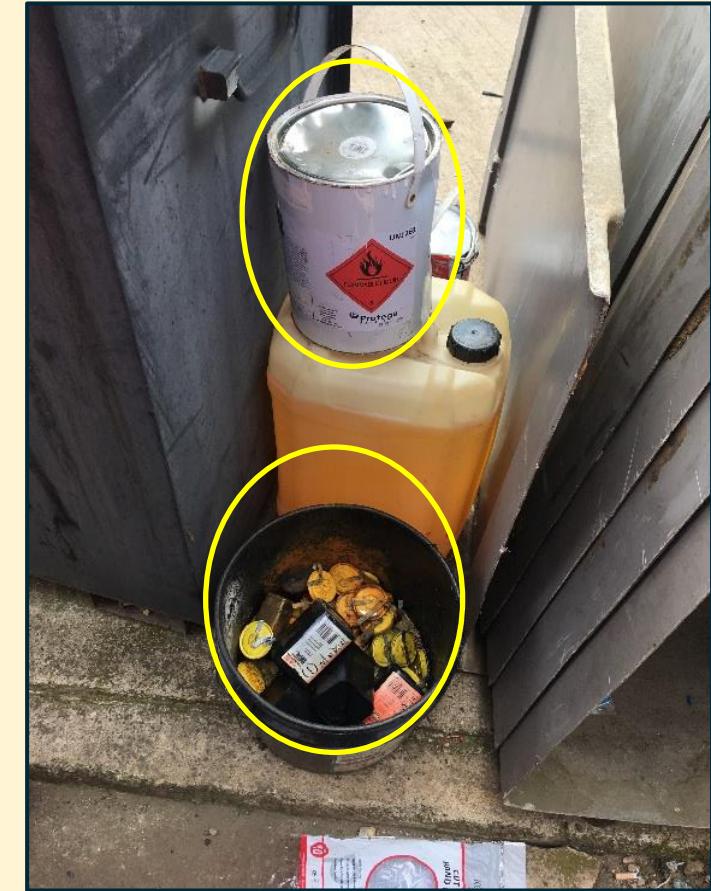
The picture to the right was taken at an equipment store in a depot within the Wessex Inner.

The bucket contained zinc chloride lantern batteries, discarded detonators and drill bits.

Behind this bucket were two tins of flammable liquid.

NR/L3/MTC/RCS0216/GA16 states: **Detonators must be disposed of in accordance with NR policies using APPROVED disposal procedures** (please refer to the notes for the information on disposal).

NR/L3/MTC/RCS0216/GA12 states: **Dispose of batteries safely using the correct disposal bin.**

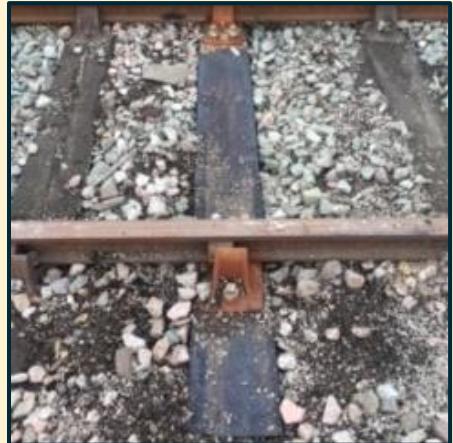
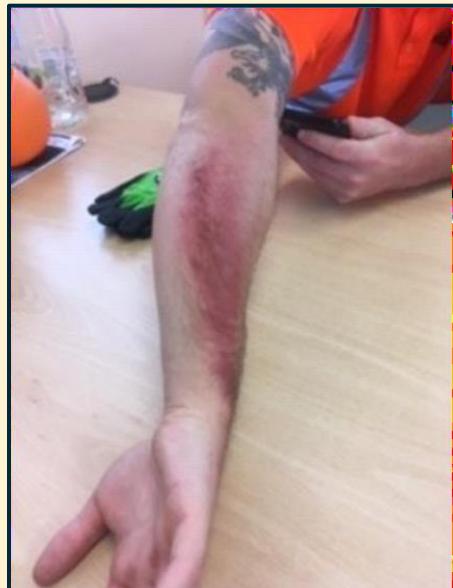
2 of our staff were recently exposed to some creosote treated sleepers. The staff were only wearing short sleeved polo shirts ,as it was a warm day and they were unaware that creosote is being used to treat soft wood sleepers.

The employees used timber/sleeper nibs to initially move the sleepers but then decided to use their hands to do the final adjustments.

1. Use the sleeper nips to move the sleepers into & out of the bed
2. Protect your hands with gloves
3. Keep your skin covered at all times
4. Wash your hands before Smoking & Eating

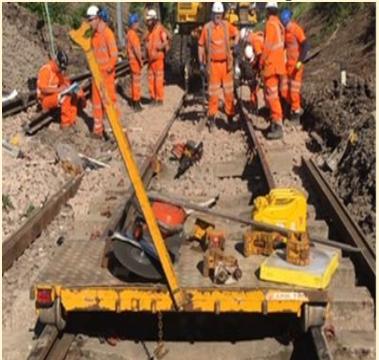
There have been several incidents nationally where staff pushing trolleys fell and were hit in the face by the trolley brake handle. This would not happen if the trolley push bars were in position.

It was discovered that staff are using the brake handle to push the loaded trolley. This is unsafe and unsuitable.

No push handles in place

Hand Trolley's must be properly assembled in accordance with the (OEM) Original Equipment Manufacturer instructions

A visual check of the brakes must be made before placing the Hand Trolley on the line, and its brakes must be tested by a push test before it is loaded or used. Push bars, Side boards and End boards must be the correct type supplied by the OEM.

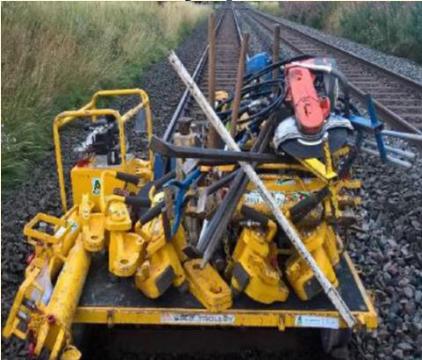
All trolleys should come with push bars and a proper brake handle. Also, the brake handle should never be tied or secured in the “Off” position!

This creates the potential for a runaway, push handles have been mandated.

Brake handle tied in the “off” position

Only the braking lever supplied by the OEM may be used to operate the brakes.

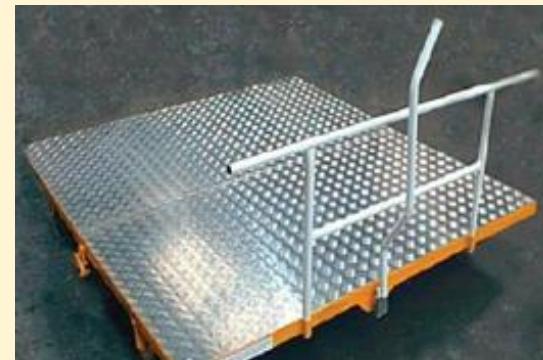
Correctly set up trolley
