A Day out with Thomas on the Watercress Line August 2019

Health, Safety and Environment Period Cascade for P05 2019/20
Wessex Route

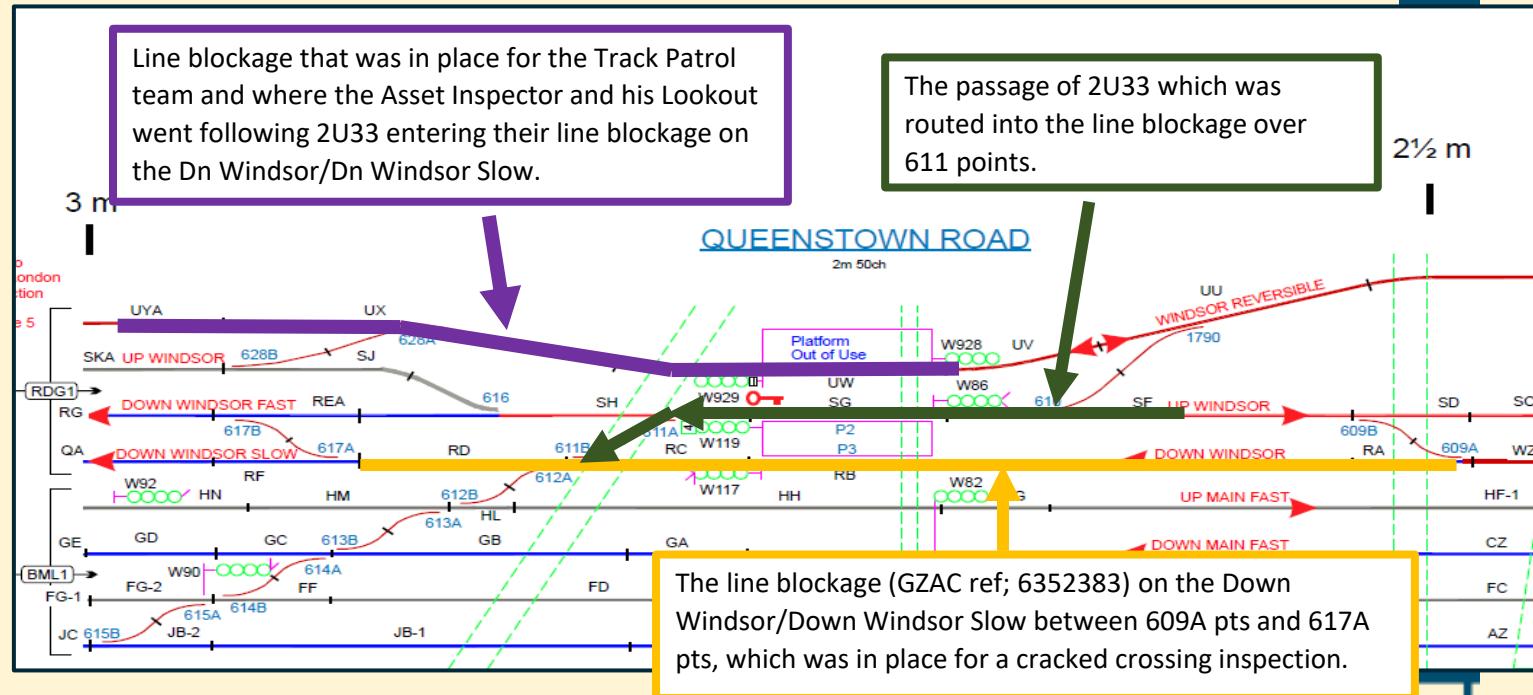
Line Blockage Irregularity at Queenstown Road Station

On Thursday 15th August 2019 at approximately 12:31 the Signaller operating panel 2 at Wimbledon Area Signalling Centre (ASC) received a request for a LB that was required to undertake daily inspections on a cracked crossing associated with W612A points at Queenstown Road.

The COSS was calling from a POS and required the LB to provide a safe access back to the platform at Queenstown Road after having previously taken the same LB at around 12:00 hours. At this time the Signaller was already dealing with another two planned LBs in the same geographic area and advised the COSS he would call him back once there was a suitable gap in the train service.

At approximately 12:35 the Signaller contacted the COSS and advised him that he was in a position to grant the LB, confirmed the protection limits and issued an authority number.

Shortly after, at approximately 12:38 the COSS contacted the Signaller to advise that he had observed a train (2U33) traverse W611 points, which were within the limits of his LB.

- This incident is currently under investigation but the initial findings suggest that the Signaller was dealing with 6 different line blockages at the time
- The review of voice comms also showed that the Signaller had 17 Safety Critical Communication conversations in a space of 45 mins, 15 of these were associated with the 6 line blockages
- Maintenance are working with the local Operations team on the reduction in multi-part line blockages

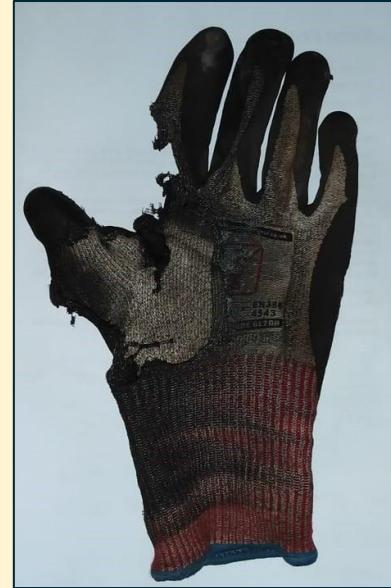
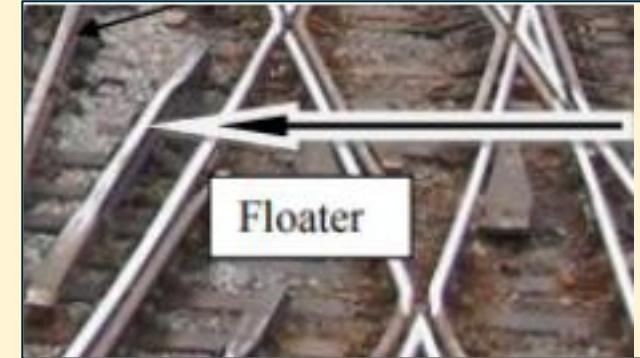
Serious Accident – burns to hands

A serious safety incident occurred on South East Route in the early hours of Wednesday morning 7th August 2019 when a colleague setting up site lighting came into contact with a live conductor rail floater which was believed to have been isolated (example of a floater on the right).

The IP suffered severe burns to their hands. However, this could have been a lot worse but the IP was wearing flame retardant PPE and gloves at the time. The investigation is currently ongoing but we'd like to issue a few immediate reminders.

- Always assume that the third rail is live and test before touch
- Are you aware of the location of live floaters in your worksite?
- Always wear the correct PPE for the task
- Are you indicating live floaters on site using devices such as self con rail indicator devices?

Never assume equipment is isolated – always test before touch.

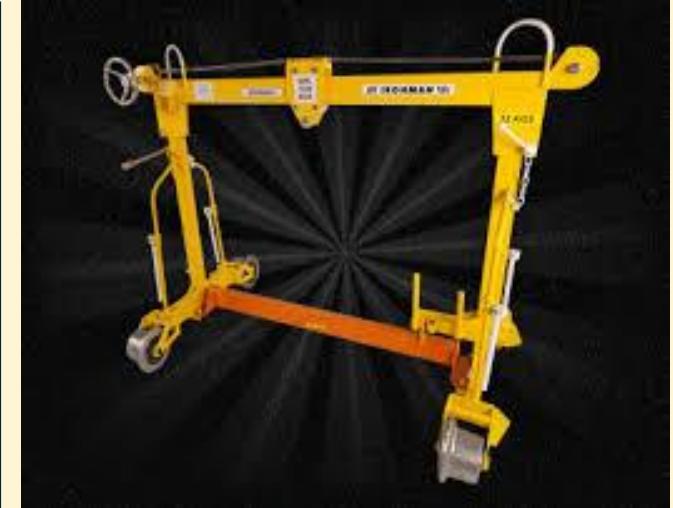
Lower back injury

On the 7th of August 2019 a Team Leader from Woking P-Way was part of a 4 man team lifting an Iron Man onto the running rails at Woking East (23m70ch, BML1).

The Team Leader was acting as the PIC and took charge of the Iron Man lift.

The team lifted the Iron Man close to the rail, then lifted it onto the Up Fast line, crossing over the running rail and conductor rail.

The Team Leader was situated on the back left end of the Iron Man and whilst lifting it into place, a piece of ballast gave way beneath his foot and he experienced a pain shooting up his back. The IP was unable to return to work on his next shift.

The lighting was deemed sufficient as the team had their head torches and there was also light coming from the lights within the siding and from the street lamps along the nearby road.

- If you are working in the hours of darkness is your lighting suitable and adequate so you can identify any potential hazards?
- Do you 'Take 5' before, during and after a task, to risk assess the hazards and discuss how the task will be done safely?
- Do you consider alternatives to manual handling? Is there a way to complete tasks by the use of mechanical means?

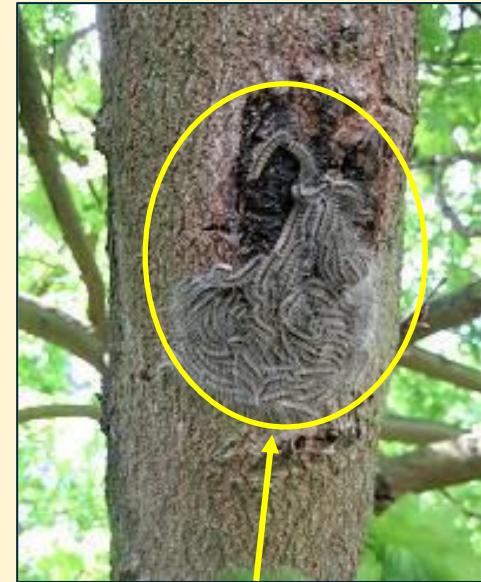
A member of the Inner Off Track team was recently exposed to hairs from oak processionary moths.

After completing the task the individual was removing his protective coveralls. It is believed that it was at this time the hairs were released and came into contact with the skin on his arms as he was wearing a short sleeved shirt underneath.

The individual later noticed a rash on his arms and during that evening had impaired breathing. The contact exacerbated his asthma. Medical advice was sought.

The OPM caterpillars gathering on the trunk of an oak tree.

If an oak tree is identified as containing an OPM nest, it must be reported to the WICC and the caterpillars kept away from.

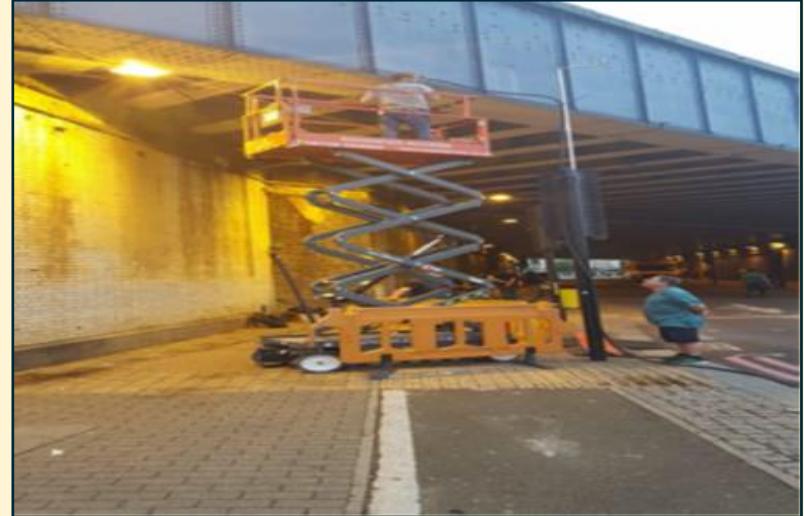
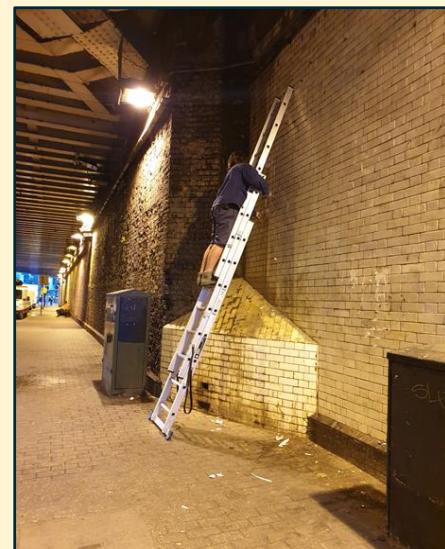
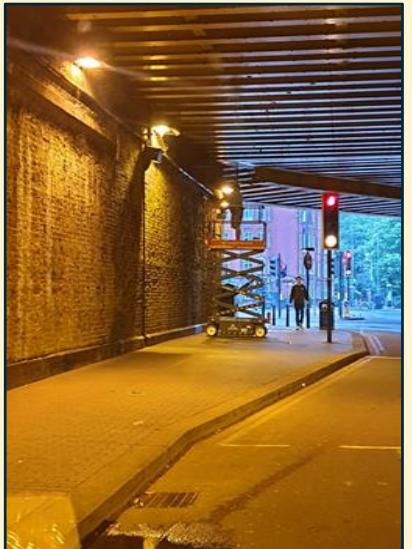
Lessons Learnt: Unsafe Working Practice

Two contractor rail safety supervisors RSS working for NWR Asset Protection and Optimization (ASPRO) , whilst supervising works by a film company's contractor installing lights to the iron work underneath the South Lambeth Place bridge in London, observed unsafe working practices which they photographed but didn't challenge and report.

Post project, ASPRO asset manager whilst reviewing the RSS site reports, came across some photos taken by the RSS depicting the unsafe work.

The RSS explained they were of the impression their role was only to ensure there was no damage to the asset and, were unaware they could challenge unsafe work. They further stated that they were not given a formal briefing before they were put to work.

- Regardless of your job role, you have a moral and legal responsibility to take reasonable care for your health & safety and those of other persons affected by your acts of omission
- Do you feel empowered to challenge unsafe work, and what is your attitude to being challenged?
- How can you highlight potential risks to those you work with?
- Are we providing our people with the necessary information they need to carry out work safely?

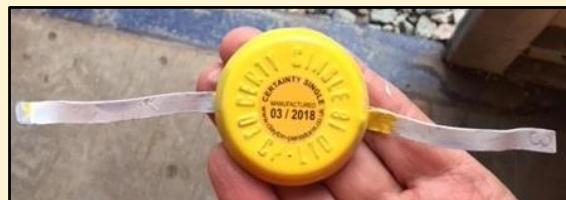
Detonator

- Detonators should always be carried in approved carrying tubes and should be prevented from rattling around in those tubes by filling any excess space with paper or cloth.
- Detonators should never be left lying around in vehicles, accommodation or on site. They should either be within the personal responsibility of an individual who has them for a specific purpose, or they should be locked away in a secure location.
- For Network Rail vehicles a maximum of 24 detonators can be kept in the manufacture's containers and stored inside a locked metal storage container within the vehicle.
