Health, Safety and Environment Period Cascade for P06 2019/20
Wessex Route

Welcome to your Health, Safety and Environmental Cascade for Period 06 2019/20. Please discuss and share the items that are relevant to your teams and display any relevant Safety Bulletins or Lessons Learnt on your notice boards.

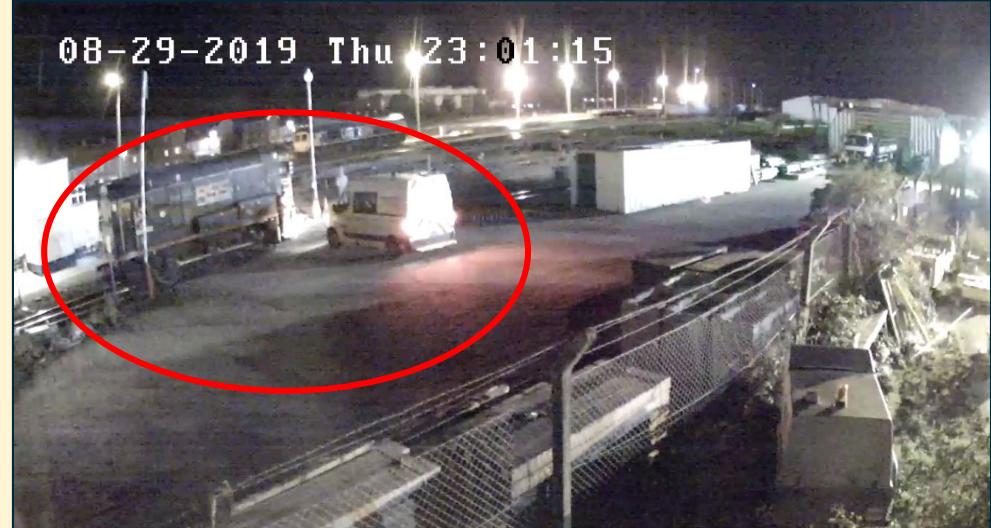
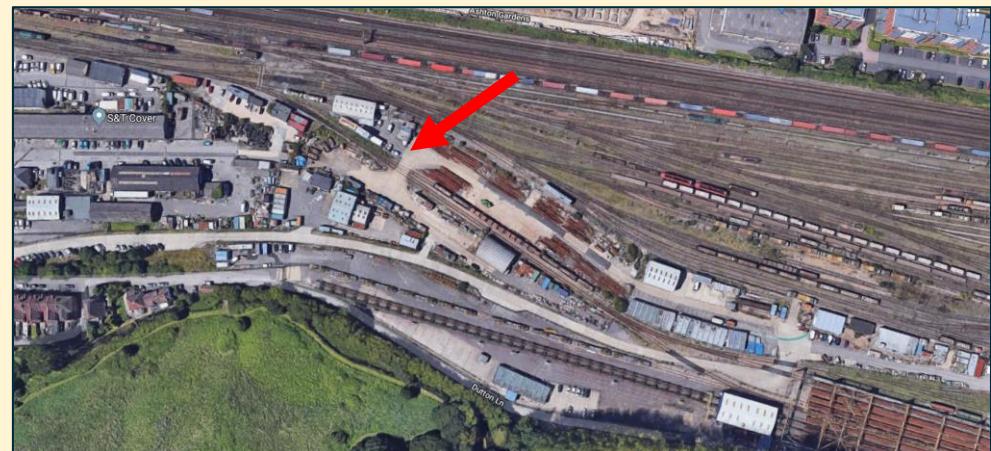
In the early hours of Friday 30th August 2019, the Outer DU RT&L team reported that a close call took place at Eastleigh Yard. The team were leaving their depot to travel over the crossing into the material yard, when they noticed an approaching shunter without any lights. The driver was at the back and there was an operative hanging off the front of the unit. The hand barriers were not lowered but the NR driver managed to stop the van in time. When challenged why the barriers were not lowered, the operative informed the NR driver that he was not briefed to lower the barriers.

During the preliminary investigation it was established that in the past, DB Cargo instructed their staff not to operate the barriers. The drivers were briefed to proceed with extreme caution when approaching the crossing and there was a sign at the crossing, warning road vehicles.

Stand Down briefing was held on Wednesday 4th September by GBRf (who now operate the Eastleigh Yard on behalf of SCO) and an instruction issued to all staff working at Eastleigh Yard to always lower the hand barriers to road traffic when rail movements are taking place.

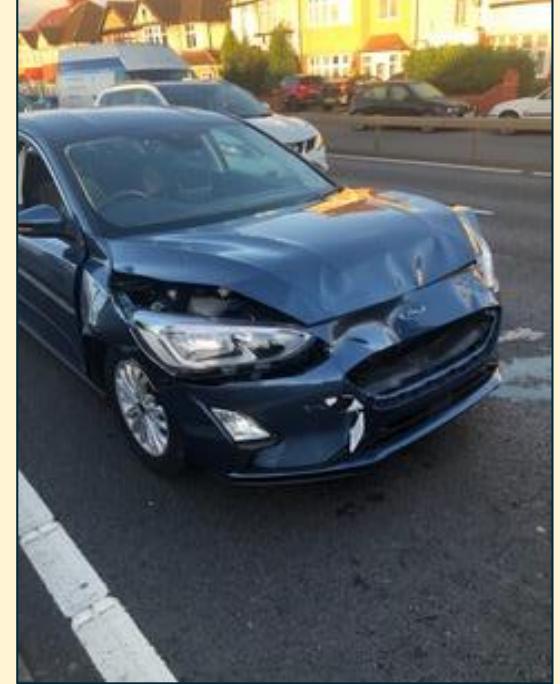
The NWR hire vehicle drove into the back of the car immediately in front and the airbag failed to deploy on colliding with the other car.

- The vehicle will be a subject to further investigation to establish the cause of the vibrations, the reason for the airbag deployment failure and whether the breaks were functioning correctly.
- If you think that there is a problem with your vehicle, don't drive it. The hire company can collect it, it's not worth taking the risk.
- Seatbelts save lives, the evidence is above.
- Carry out your vehicle checks before you set off.

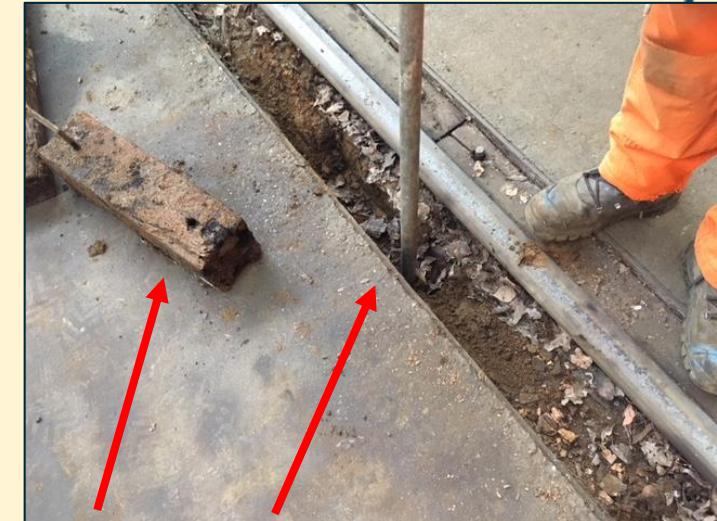
On the 10th of September 2019, an Operative from the Off-Track Team suffered a painful back strain when he was prying up a timber bearer using a heel bar.

The team was tasked with manually removing rotten timber bearers and the inlays, which sit alongside the running rails, throughout the 4 lines within the Effingham MPV sheds.

An inlay and a heel bar within the MPV sheds

- Are we using the right tools? Manually carrying out work maybe the easier option, but it might not be the right one.
- Do we protect our people? Have we given them every chance to succeed, without putting them at risk?
- Are we taking the repetitive nature of our manual handling into account? A one off lift may place incredible strain on our bodies, but it is short lived. Work of the type identified in this incident may not be so straining in the short term, but by the nature of its repetitiveness may cause longer lasting effects.

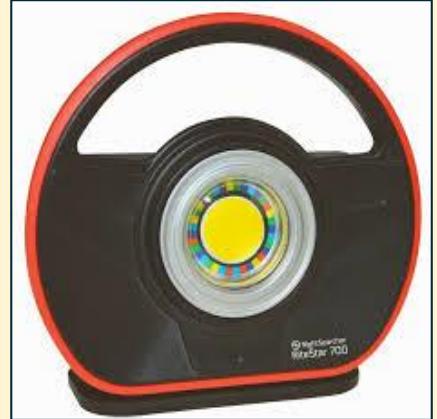
RiteStar 700 NightSearcher magnetic light

- Is the site lighting suitable for the work being undertaken? Head torches are useful, but consider other lighting, such as the RiteStar 700 NightSearcher light. This magnetic light could be attached to your Iron Man or a trolley.
- Beware of your underfoot conditions and watch out for any uneven ballast surface
- Think P.R.I.C.E.
