Route Asset Manager- Buildings & Structures**PLANNED PREVENTATIVE MAINTENANCE(PPM) WORKS – SEVERE LACERATION TO ARM****INCIDENT**

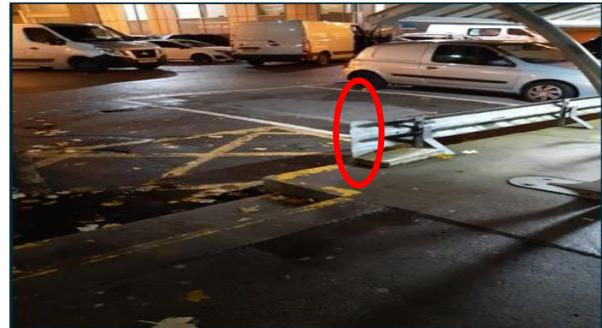
As they approached the carpark through the side walkway leading to a set of 2 steps, a member of the group lost his footing and fell forward on the steps. As he fell, his inner right arm came in contact with the vertical end section of an armco barrier, causing severe lacerations to his arm.

- The IP had become engaged in a conversation with the PiC as they returned to their vehicle
- The end section of the armco barrier was unprotected in a highly pedestrianized location
- The car park street light directly above the steps, was not operational at that time
- The IP had declined to attend treatment at the nearby hospital and drove himself to his local A&E in Poole, accompanied by a colleague
- Underfoot condition was wet with puddles of water on approach to the car park.

- The need to always be alert and aware of your environment for the entire duration of work and to go home safe everyday
- Accidents can occur at any time and any place, including at the start and end of shifts, and change overs
- The need to review the risks of unprotected armco barriers and hoardings around pedestrianized locations across rail assets
- The need to always follow established emergency protocols to ensure yours and other people's safety.
