Health, Safety and Environment Period Cascade for P10 2019/20

Wessex Route

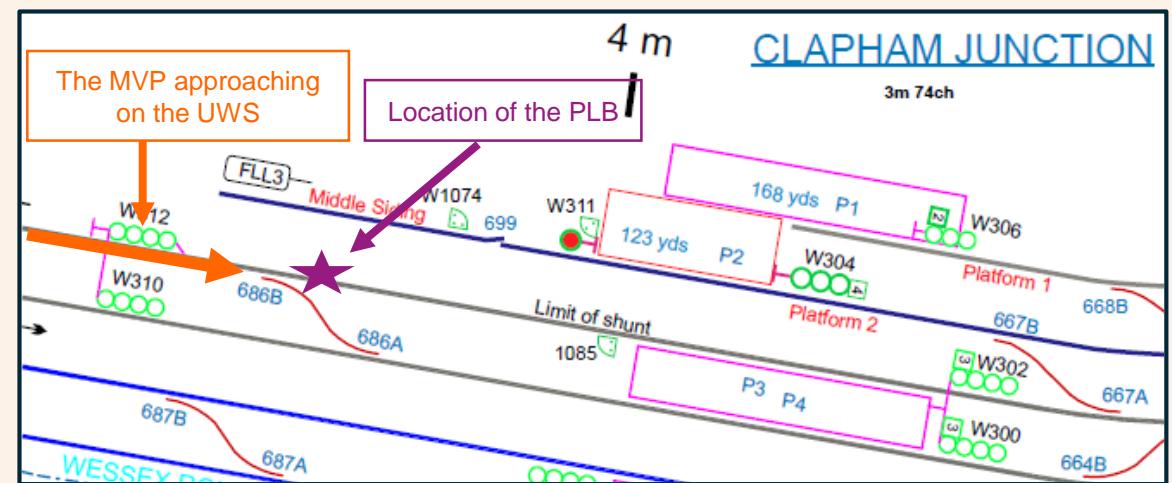
## Line Blockage Irregularity at Clapham Junction

On Friday 13<sup>th</sup> December 2019 at approx. 11:49 the driver of 3S85 (MPV train) had to apply an emergency brake as he observed 2 members of staff and a PLB in his path as he was approaching Clapham Jn station on the Up Windsor Slow line (RDG1).

The signaller at Wimbledon ASC earlier granted 2 line blockages, one for the DWS and the other for the UWS. The signaller received a request to clear the line blockage on the DWS but removed the collars for the UWS line blockage and subsequently cleared the signals for the waiting MVP train.

1. An urgent review that looks at application of reminder appliances in association with each planned patrolling line blockage
2. Implementation of ZKL3000 remote control T-COD's in this particular location

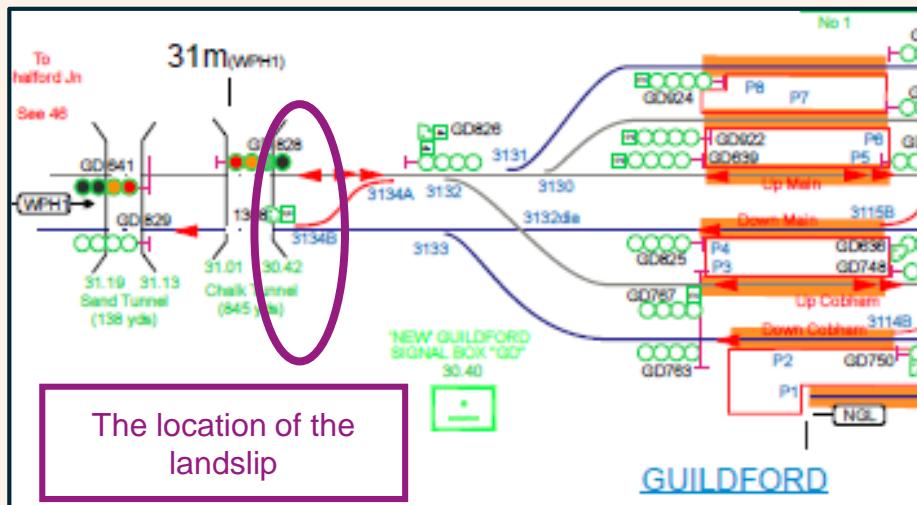
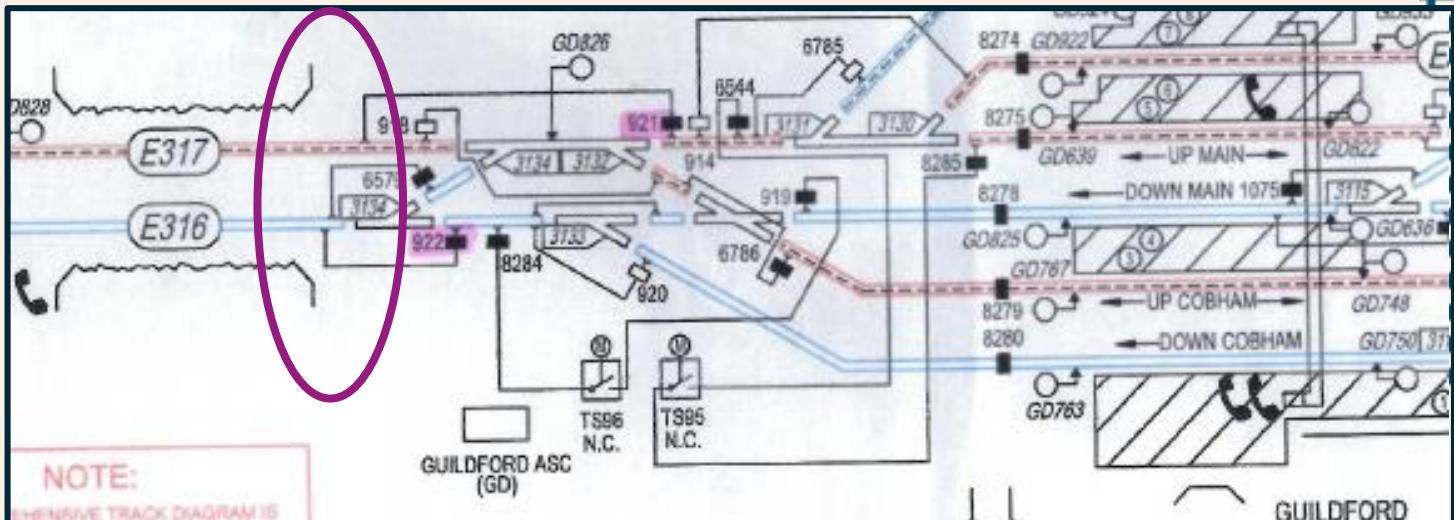
## Strapping Irregularity at Chalk Tunnel

On Friday 20<sup>th</sup> December 2019 at approx. 11:10 a strapping irregularity occurred at Chalk Tunnel, C/E of Guilford Station. Due to an earlier land slip that blocked both the Up and Down Main lines, the maintenance teams were clearing all the spoil from the site. It was established that a temporary isolation (TI) was required to enable the staff to carry out the task safely.

As part of the TI a number of circuit breakers and hook switches were open. A short circuiting bar was applied on the incorrect side of the H/S 921. This resulted in a flash and tripping of the circuit breaker E317. Fortunately there were no injuries.

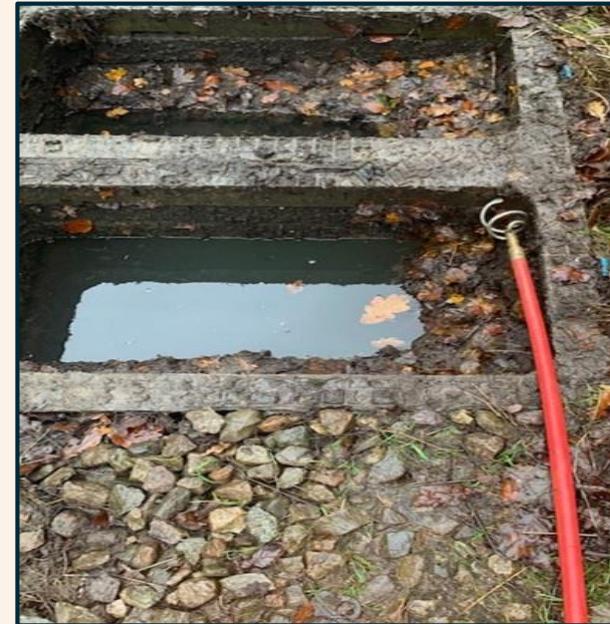
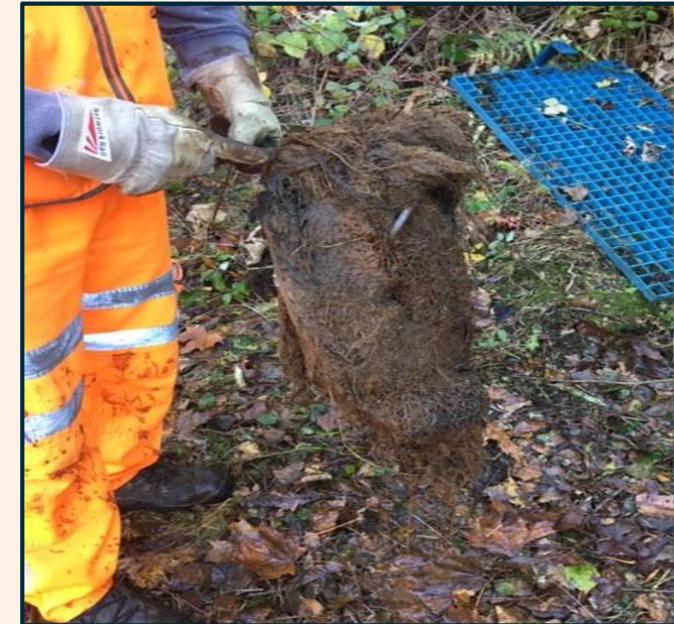
A cork-screw or 'pigs-tail' was fixed to the first rod and further sections of rods were added until the blockage was reached and a handle was then attached. The IP began to wind the handle with his right hand supporting the rods with his left.

Experiencing resistance, he attempted to use his strength to tear through the obstruction. The blockage did not yield and the torque built-up until the handle slipped from his hand, springing back, striking the IP and dislocating his left index finger in the process.

"Pigs Tail" attached to a drainage rod and roots removed using the attachment

- Take 5 – could the team have thought of a better way to complete their work, or to assess what they were up against?
- The IP attempted to force his way through using brute strength and tension built up in the rods rapidly. Would a slower, considered approach allowed the situation to be assessed more accurately?
- Do not attempt to reset any dislocated fingers yourself, seek a prompt medical advice

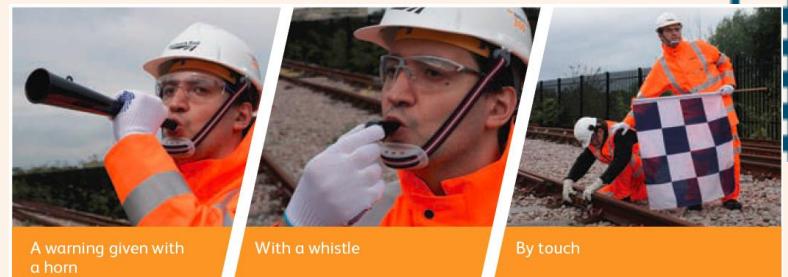
Lookout warning is using an unassisted lookout, the warning is given by horn, whistle and touch if there is noise or the group are wearing ear protection. A lookout may also use a cut off device on noisy equipment or plant.

A warning given with a horn

With a whistle

By touch

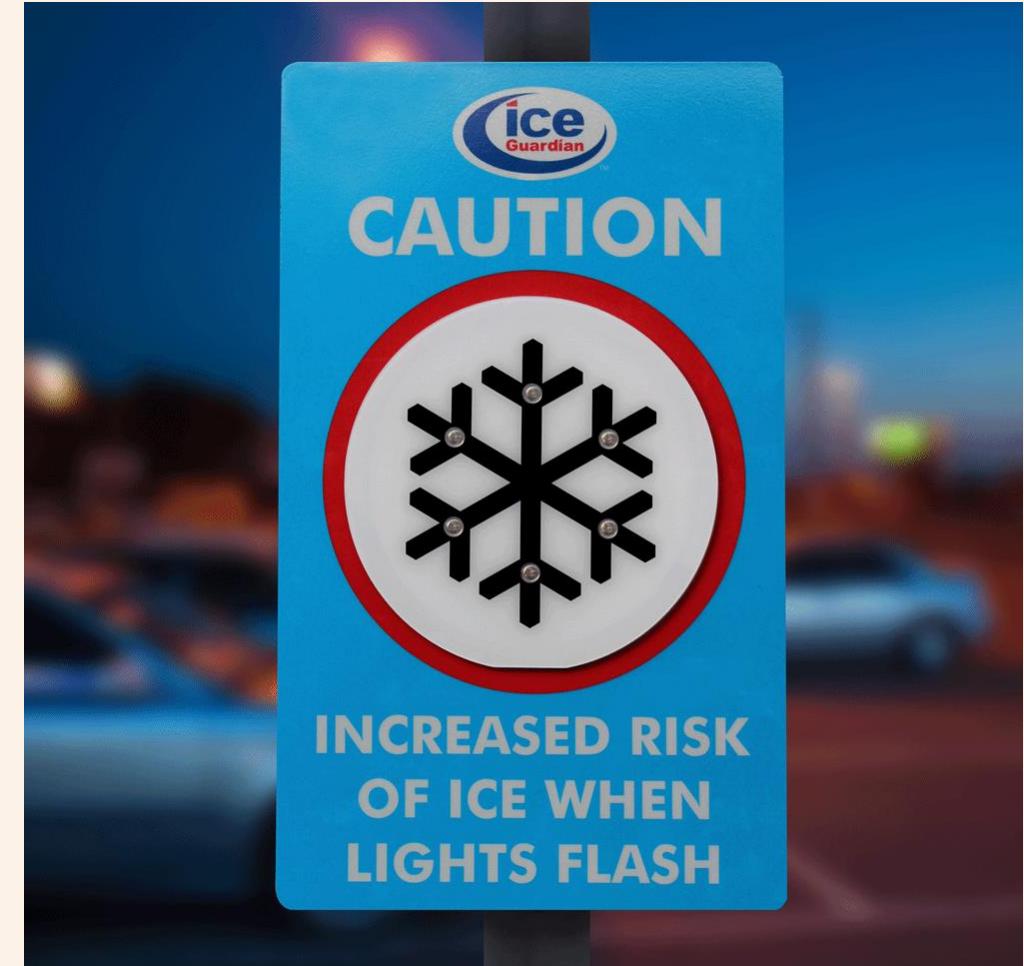
The Ice Guardian warns the users of a greater risk of black ice forming by flashing when the temperature drops to 3°C and below.

Using super-bright LED technology, the Ice Guardian grabs attention by enabling the flash to be seen in the user's peripheral vision.

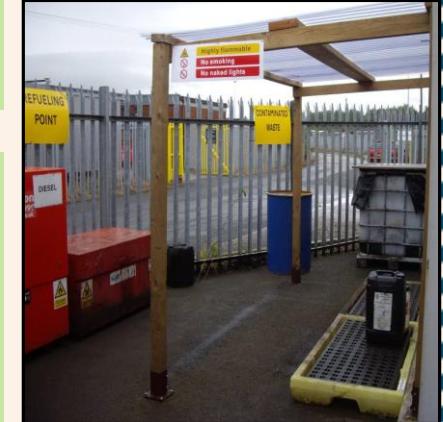
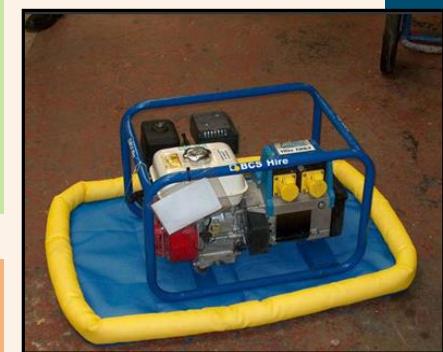
- All chemicals and oils should be stored securely and in suitably labelled containers. Good practice is to ensure that all storage containers are appropriately bunded or stored on a drip tray and ideally under a shelter, these should be regularly inspected. Contaminated rainwater should be disposed of as hazardous waste.
- Chemicals and oils should not be stored within 10m of a watercourse, gully or drain. Ensure that stocks are regularly reviewed and dispose of old or expired substances. Tanks and storage units should be secured and locked when not in use.
- Up to date COSHH assessments should be completed for all substances stored on site, these should be reviewed to ensure that any specific storage guidance is followed.
- Drip trays or absorbent mats should be placed beneath static and mobile plant during refuelling and a spill kit available.

- Check how your oils, chemical and mobile plant is stored.
- **Do not ignore any spillages on the ground or into a watercourse** - this needs to be cleaned up promptly and reported.
- Check that a copy of your environmental emergency procedure is displayed within depots and/or included in the Depot Environment Pack.
