Health, Safety and Environment Period Cascade for P12 2019/20

Wessex Route

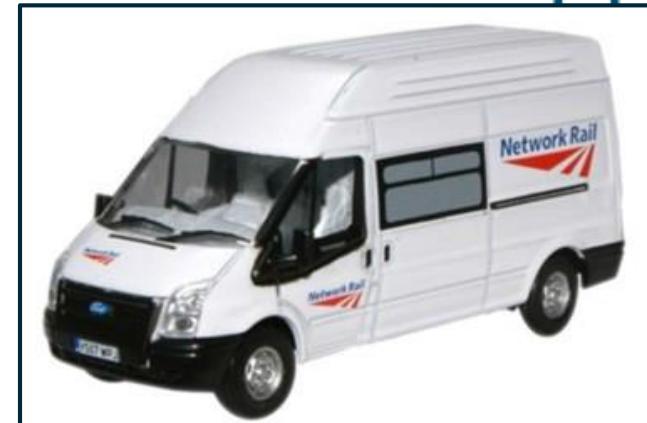
Crush injury caused by faulty van breaks at Victoria – Sussex Route

At approx. 00:40hrs on Thursday 21st November 2019 the driver of a NWR Movano van parked on the ramp down from Ebury Bridge Road at Victoria behind another vehicle. The other vehicle was a small Citroen caddy style van used by an S&T sub contractor.

The sub contractor was parked on the ramp waiting to access the track as his path was blocked by Road Rail Vehicles (RRV's). The NWR van driver left his vehicle with its engine running whilst enquiring about the access becoming clear.

Whilst the sub contractor was getting some water from the back of his vehicle, he noticed the vacant NWR vehicle heading towards him. He attempted to move out of the way but was crushed between the two vehicles. He sustained lacerations and bruising around the top of the right shin, damage to the knee ligaments and soft & deep tissue damage.

- the immediate cause - the handbrake on the NWR van was faulty and therefore not able to prevent the vehicle from moving forward down the slope
- the driver's log book showed that the driver of the van used this vehicle almost exclusively, with the last person using it two months earlier
- the driver carried out a partial but not the complete vehicle check that is documented in the driver's handbook

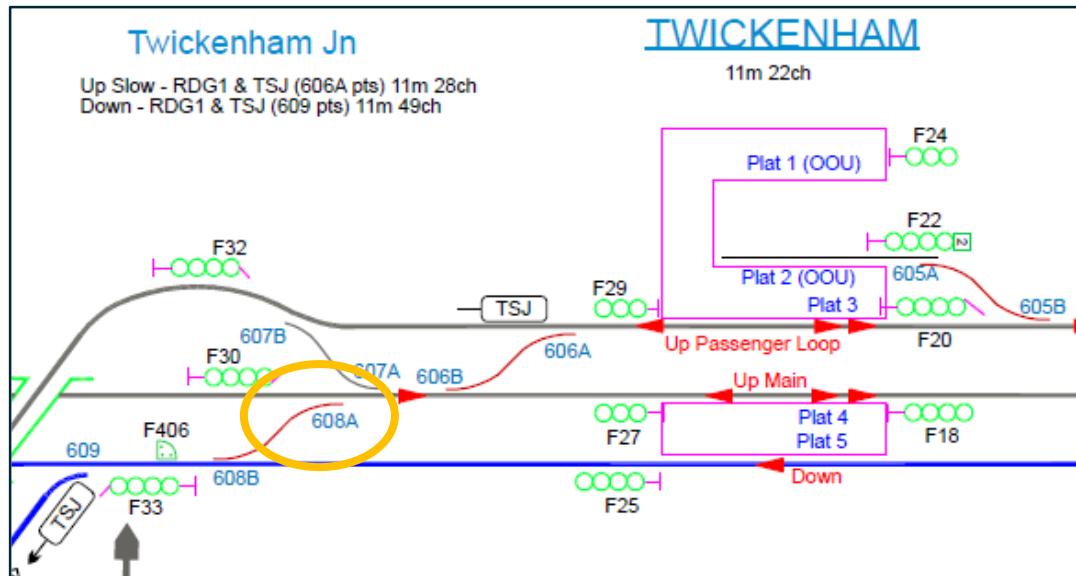
Points Run Through at Twickenham 09/02/2020 – Southern Capital Delivery

The Points Operator had taken the Til-dawn lamp off the “B” end of the 608 points at Twickenham, which had been wound to the correct position and was preparing to wind the “A” end of the points.

The Machine Controller did not check the route and authorised the RRV Operator to move over the points assuming they had been set correctly. This incident is under investigation by the Southern Capital Delivery.

Some common causes that led to previous events when points were run through:

- The Machine Controller not walking in advance of the machine and checking that the points are correctly set before authorising the machine through the points.
- Til-dawn lamps not used, removed or laying down with the Machine Controller incorrectly believing that this is authority to move through the points.
- Poor communication in not reaching a clear understanding between key staff such as machine controllers, machine operators and points operators.
- A lack of understanding on the correct position of points in complex layouts (such as switch diamonds or double slips).

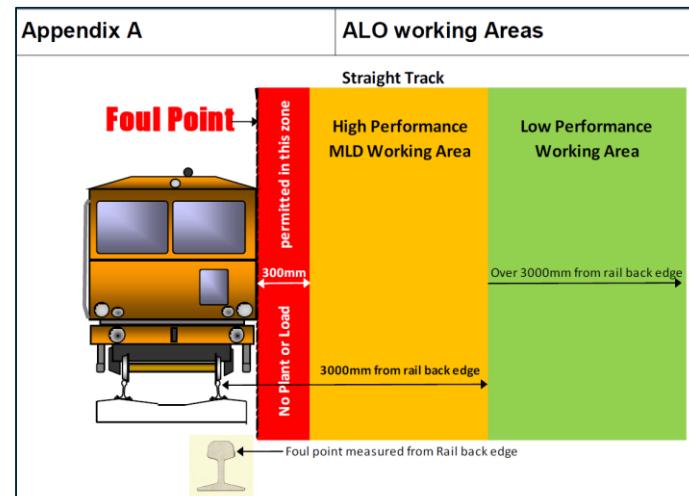
Guidance for Planning Any Line Open (ALO)

ALO Work Plan									
Authority Number 0									
Part 1 - Main Plan									
ALO Plan Originator	Originator Role / Function			Select	Site Visit Date			Title RWEX/ALO_01 Ref COP0032 Date Feb-20 Issue 1	
Delivery Unit / Team	Select			Planned Week No	Select	WON Item			
Location				Dates From		To			
Summary of Works				Times From		To			
Worksite Mileages	From	miles	Select	To	miles	Select	Select OTP / OTM Work Plan Ref		
Machine 1				Select	Maximum Gradient is:			1	in Level
Machine 2				Select	Maximum Cant is:			mm	
Maximum Reach of Machine	mm		Calculated Fouling Point (Min 900 - Max 1400 mm)			#VALUE!	mm		
Planned Limit of Work (Distance from Fouling Point)	0 mm		Plant Position (Distance from back edge of nearest open line)			mm			
Maximum Counterweight Offset	mm								
Control Systems to be used & Details of ALO Working Method									
If using HIGH performance Movement Limiting Device control system see Part 3

If using LOW performance Movement Limiting Device control system see Part 4									
Non ALO Working / Cannot Foreseeably Foul an open line see Part 5									
High Performance Control									
Details of Lines Open Lines Under Possession Lines Under Blockage	1	Line Open		Notes for Part 1					
	2	Line Open							
	3	Under Possession							
	4	Under Possession							
	5	Under Possession							
	6	Under Possession							
	7	Under Line Blockage							
	8	Under Line Blockage							
	Part 2 - Stabling Point, On & Off Tracking Point(s)								
Machine(s) position at the On / Off tracking points and controls to be used.									
Location 0		Week No	Select	ALO Plan Number			0

There must always be a documented risk assessment in place if there is an open line when plant is operated on Network Rail managed infrastructure. (See notes for further information).

The Wessex plant team has developed an ALO work plan that is currently being briefed across the route and is available on the Wessex on track plant Hub.
