# Safety Bulletin

A Serious Accident has occurred

Reference: Ankle injury

Location: Yeovil, WEY line 137m40ch, Wessex Route

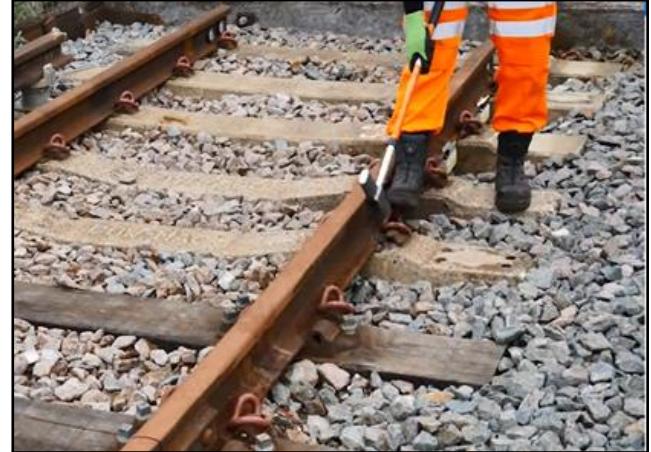
On Friday 26<sup>th</sup> June 2020, a member of staff was carrying out re-padding on the Yeovil Wey Line (WEY). The task involved removal of rusty Pandrol Clips, that were difficult to unkey, over the length of 10 chains. The method employed was to strike the seized, frozen clips with an unkeying hammer.

Whilst in the process of striking one of the seized clips, the hammer glanced off the web of the rail and struck the individual on his left ankle.

- The management of physical and mental fatigue during arduous and repetitive tasks;
- Alternative methods to remove seized or difficult fastenings including the use of penetration oil;
- Please refer to the following Task Risk Control sheets for more information regarding the safe removal of frozen Pandrol Clips and unkeying rails using a hammer;
  - [NR/L3/MTC/RCS0216/TK49](#) Remove Frozen Pandrol Clips.
  - [NR/L3/MTC/RCS0216/TK65](#) Unkeying Rails using a Hammer.
