Team talk

& Safety brief

Period 8

Our periodic video and discussion pack for everyone in Wessex

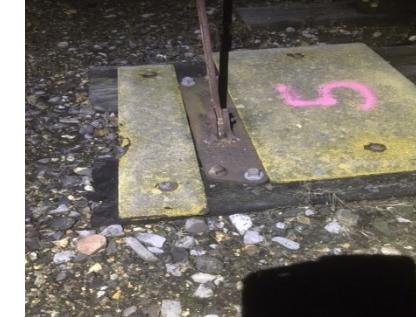
Andover Up Siding/Yard, BAE1 66m20ch

On Wednesday 4th November 2020, a member of staff was setting up a worksite in preparation to fix a rail defect. With the assistance of another team member the Injured Person (IP) had collected the Stressing Saddle from the vehicle and proceeded to carry it, to the rail trolley to be transported to the site of work. The team thought about the requirement for manual handling and parked their vehicle as close as possible to reduce the carrying distance.

On stepping over a rail, the IP missed his footing catching the rail. Unable to stop the fall, the IP struck his left leg on the rail, but his right side of chest landed on a screw spike.

Initial assessment and First Aid were given on site, but a decision was made to transport the IP to hospital for a check-up. Whilst X-ray's and scans identified no breaks or internal damage, the bruising to the chest area was significant and the IP was kept in hospital for four days followed by a significant period off work to recover.

- How you assess the worksite to identify potential hazards that could cause an incident and/or injury.
- Being aware of worksite hazards and taking extra caution when moving heavy equipment.
- Being aware that even the most innocuous fall could result in potentially serious injury that should not be overlooked or dismissed. A hospital check-up should always be considered.

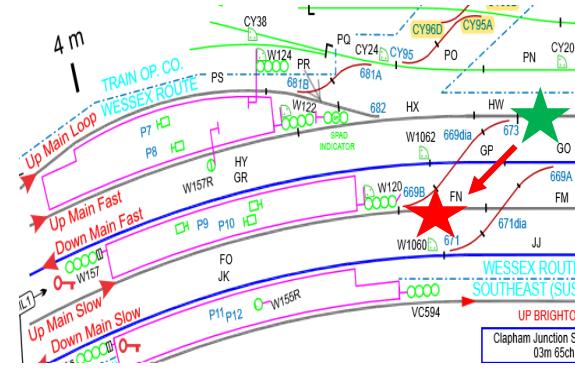
Clapham Junction, Up Main Slow line BML1

On the 14th of November 2020 at approx. 04:00, after completing work in an ES worksite under T3 protection with an isolation, a maintenance team (consisting of P-Way and Welding staff), moved out of a protected and isolated area into an open line and caused an electrical incident when an item of grinding equipment came into contact with a live conductor rail.

The group, under the control of a PiC/COSS carried a hand trolley and their equipment from the Up Main Fast line, crossed over one line and then into adjacent Up Main Slow line which was open to the movement of trains.

The decision to move from the protected line was made by the PiC/COSS, because it was believed a set of points were set against the movement, this was not questioned by others within the team.

- Do you have the necessary local knowledge and are you fully conversant with the diagrams and maps within your Safe Work Pack and the information included in your Conductor Rail Permit? **Do you know where you are?**
- Do we take the time to '**Stop, Think and Take 5 for Safety**' or do we let the situation that may be unfolding around us take the lead in the decisions that we make?
- Do we feel empowered to challenge our colleagues, no matter their position or standing if they are doing something that **we** think may be unsafe?

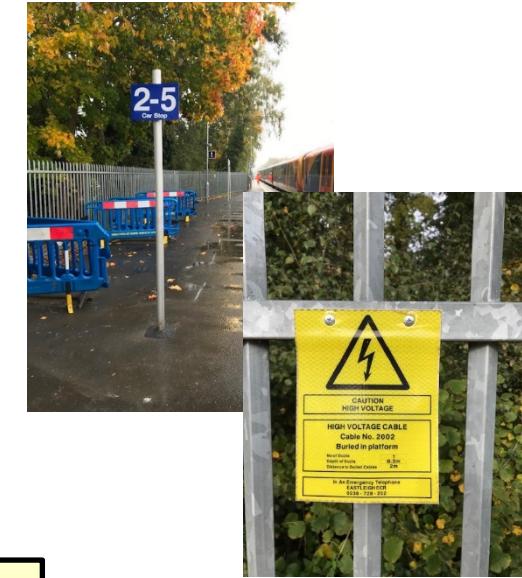
Cable Strike at Fleet Station

On Monday 26th October 2020, a contractor working on behalf of SWR was erecting car stop signs on Platform 1 at Fleet station.

The team proceeded with the excavation without having a buried services survey carried out first. Whilst digging they saw the cables but still chose to place the pole for the sign.

The team came unbelievably close to cutting in to a 33kV cable that would have had serious, if not fatal, implications. In the process they damaged the pilot cable which required some remedial repairs by the Outer E&P team.

- Did you know that it is quite common for our HV routes to run through platforms?
- Importance of using CAT scanners and buried services surveys before any work involving excavation on or near the line.
- Should you require buried services information in response to an emergency, please call **01904 386390** to confirm your requirements.

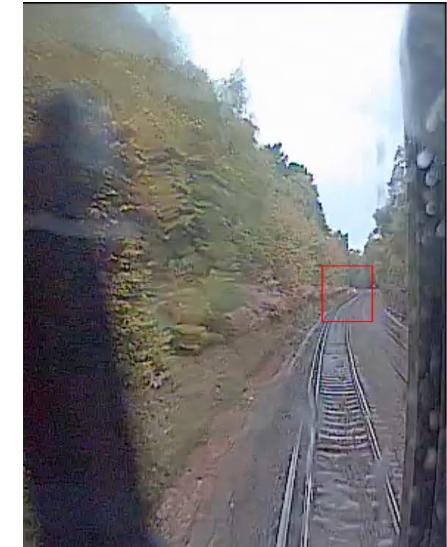
Operational Close Call at Bagshot

On Thursday 29th October 2020 at approx. 11:05 hrs, the driver of 2N23 travelling from Ascot to Aldershot on the Down Frimley line (AVV), reported an alleged Near Miss with a group of 3 members of staff carrying out HV cable inspections between Camberly and Bagshot Station.

The team were walking/inspecting the HV cable route in the cess but when they reached an area with a particularly wet and slippery overgrowth and troughing, they stepped into the 4 foot to walk past the hazardous section.

The lookout positioned at the front of the group gave a warning of an approaching train just before the driver sounded his horn, and the team moved into the position of safety in the cess.

- The preliminary investigation established that the group were in a position of safety in the Down cess for approximately 11 seconds before the train reached their location, therefore this was not deemed to be a Near Miss.
- It was also established that the train was travelling at 44mph but with the line speed of 60mph it would not have been possible to achieve the minimum required sighting distance and therefore the SSOW implemented was not appropriate for the location. The event was classified as an Operational Close Call.
- Importance of a dynamic risk assessment to ensure the SSOW in a moving worksite is sufficient and adequate.
- How do you ensure/check that you can achieve the right sighting distance, could range finders be used as an aid to assess distance on the ground more accurately?

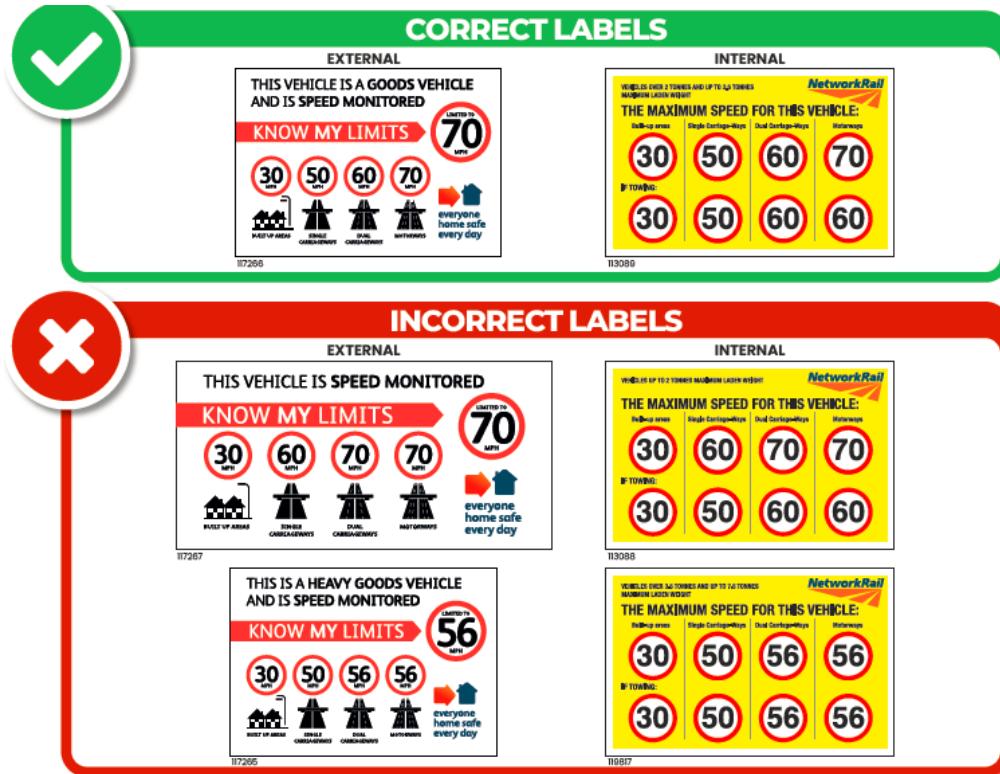
We have been made aware of a batch of Ford Transit Connect vehicles that may have been supplied with an Incorrect Speed Limit label. Could you please check these vehicles to ensure the correct label (please see below) is in position on these vehicles.

To obtain the correct stickers
please contact the Road Team
Fleet

Check the speeding stickers on your vehicles

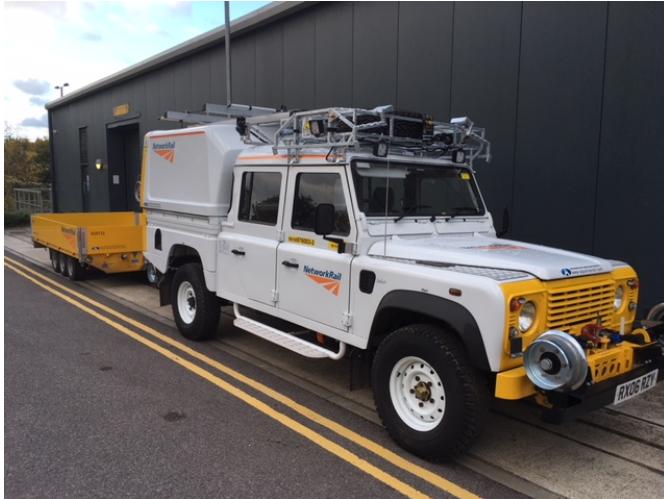
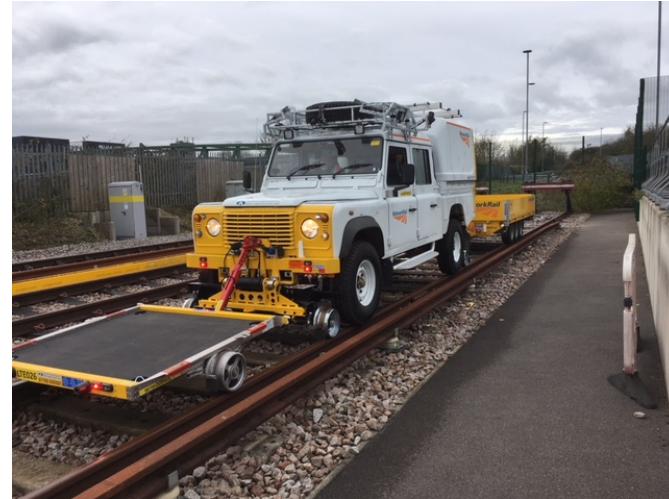
Upgraded Rail Land Rover and R2R Trailer

The third upgraded Rail Land Rover was delivered to Wessex in October

A Road and Rail R2R trailer with a payload of 2400kgs on the road and 3000kgs on rail.

Load Tray Extension trailer with a load carrying payload of 480kgs with Up & over roof rack to transport it on the road.

New directional LED lighting at the front, rear and on the sides to improve site lighting all around the site of work.

A 360 degree camera system to give the driver/operator a 360 degree view to assist with maintaining the exclusion zone.

Repainted white to comply with the our NWR road fleet with new NWR signage.

Seating for 6 occupants with seatbelts and personnel carrier MC controls in the rear compartment.
