Sheerwater substation was upgraded from a Track Paralleling Hut (TPH) to substation c2005. The AC module and transformer/rectifier set are located approximately 350m north of the original TPH. Six 750V 1000mm² interconnector cables were installed to extend the DC busbar from the TPH to the new substation. Due to the length of these cables, a Siemens DC differential system was installed to protect the DC interconnector. The basic protection system as below.

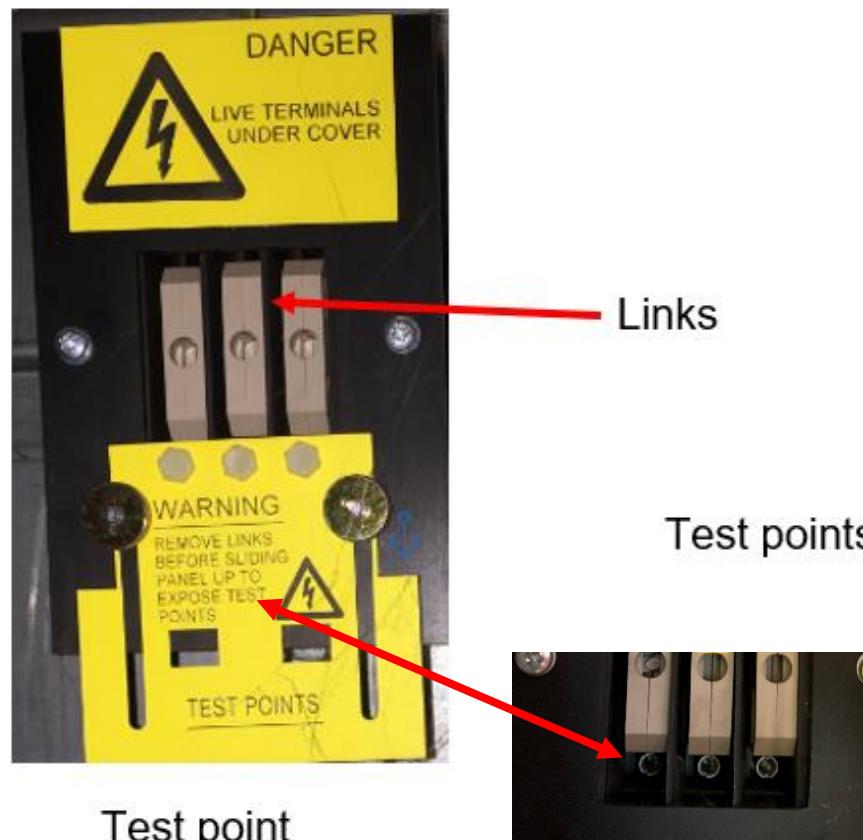
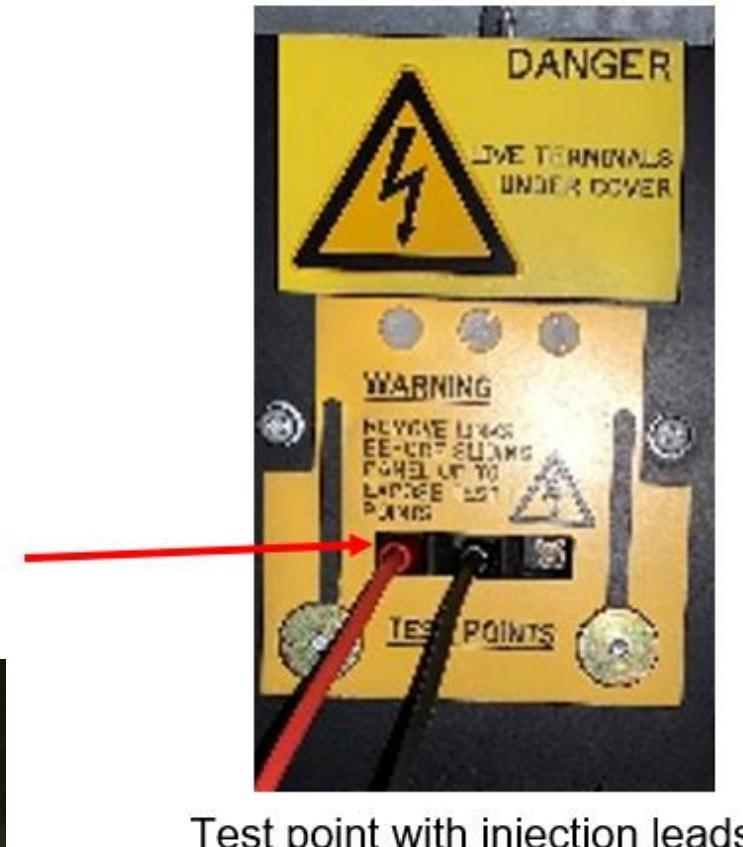
The test blocks used in the circuit are of the type shown below. The 750V shunt wiring enters at the top. Links are removed to isolate the shunt wiring. Test points are provided at the bottom. A yellow cover is raised and secured, permitting access to the test points and enabling milli volt injection of the buffer amplifier circuit.

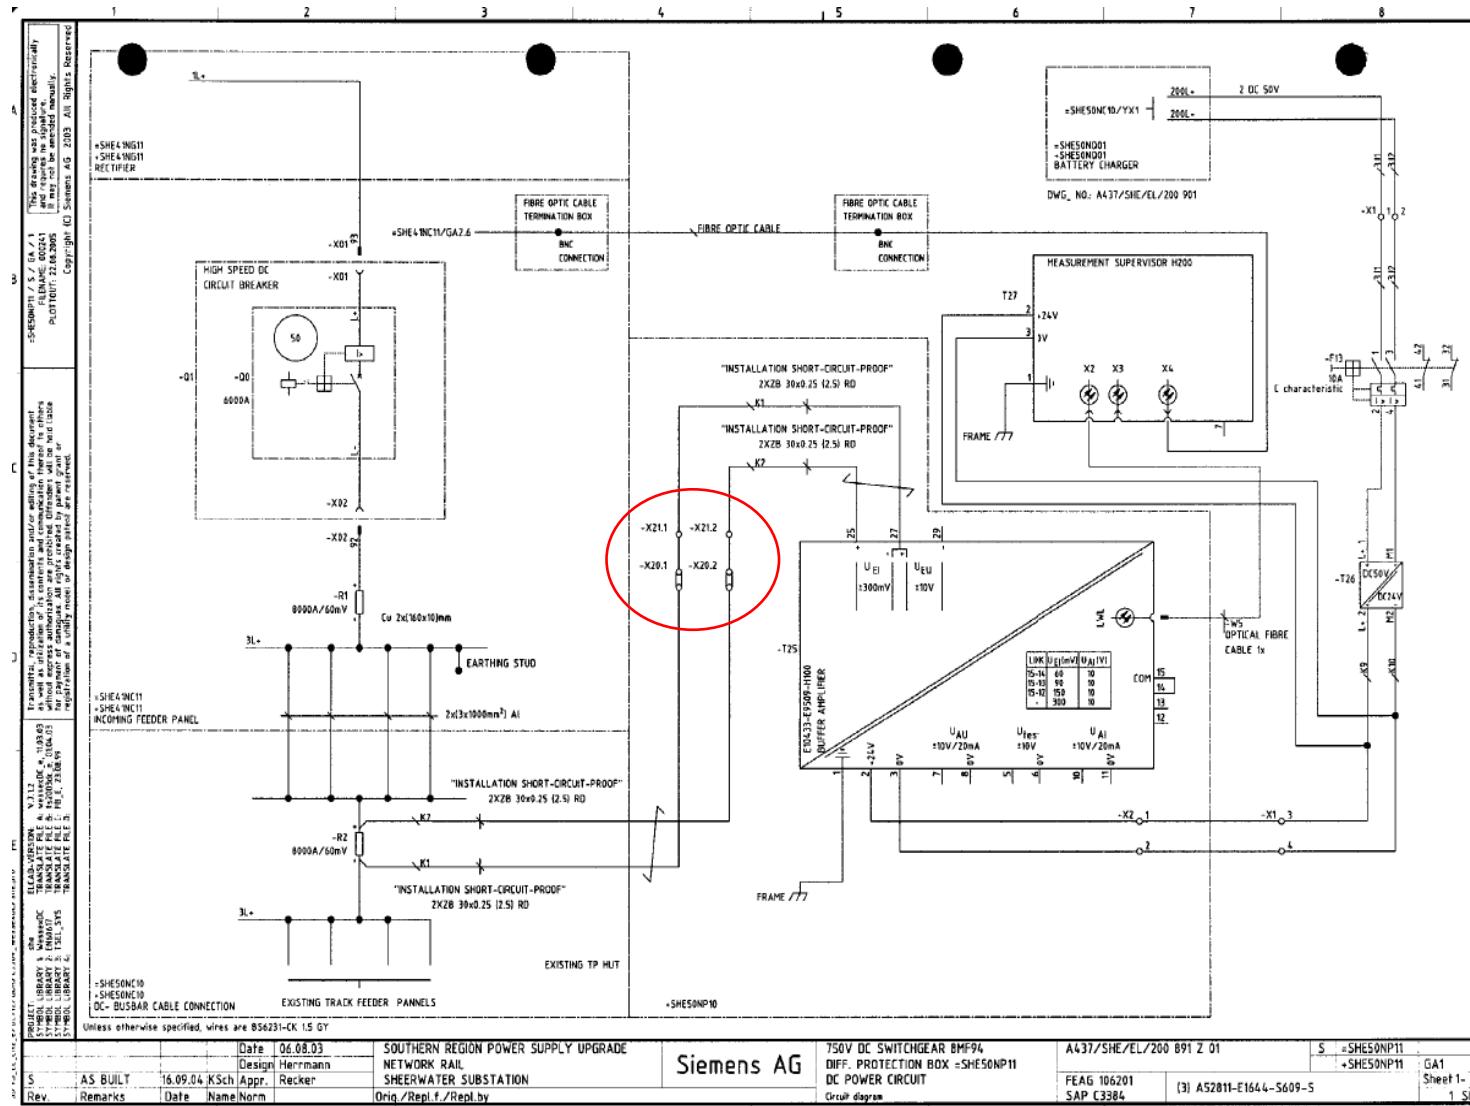
The arrangement of the test blocks can be seen in the schematic below, with the links disconnecting the shunt and providing a safe, isolated test point.

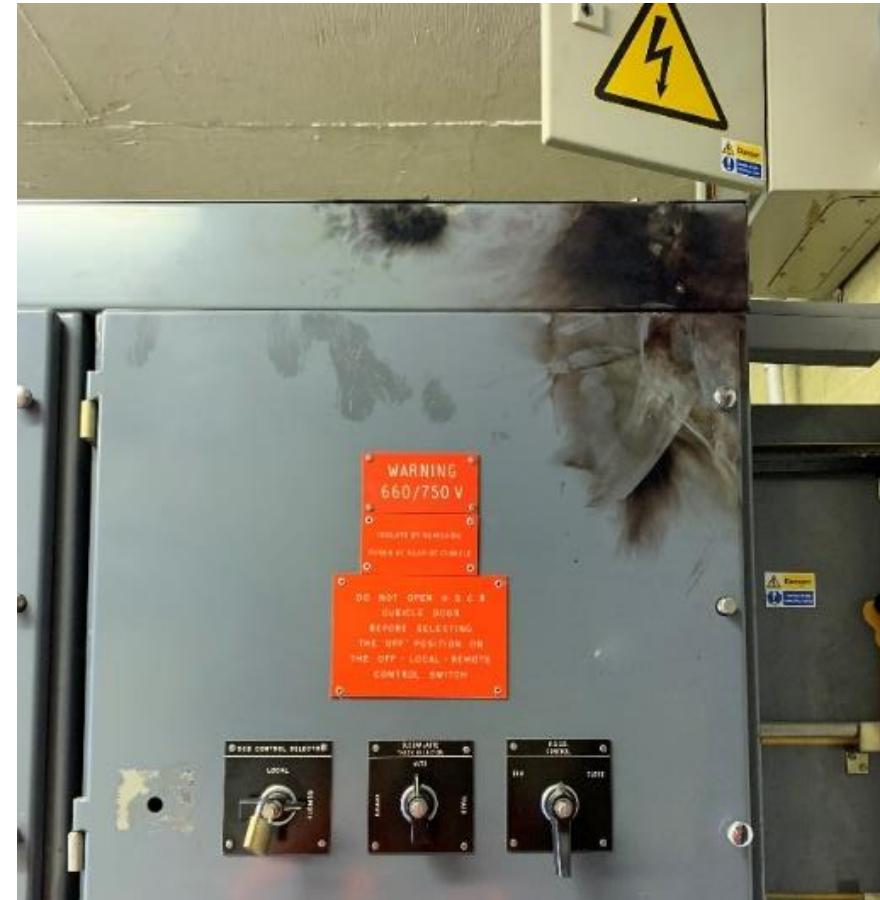
In preparation for testing the buffer amplifier, the operative correctly withdrew the links and connected the millivolt generator leads. Whilst completing the set up, a disconnected lead came into contact with the frame of the DC switchboard and flashed over to earth. The test point was checked and found to be live at 750V although the links had been removed.

The wiring error could not have reasonably been foreseen. The intent of the lifesaving rule “*Never assume equipment is isolated – always test before touch*” is not directly applicable to the activity of connecting test leads to an isolated protection circuit. It is however, best practice and a reasonable extension of the principle. Staff are therefore reminded to always test isolated protection circuits for dead before applying test leads or equipment.

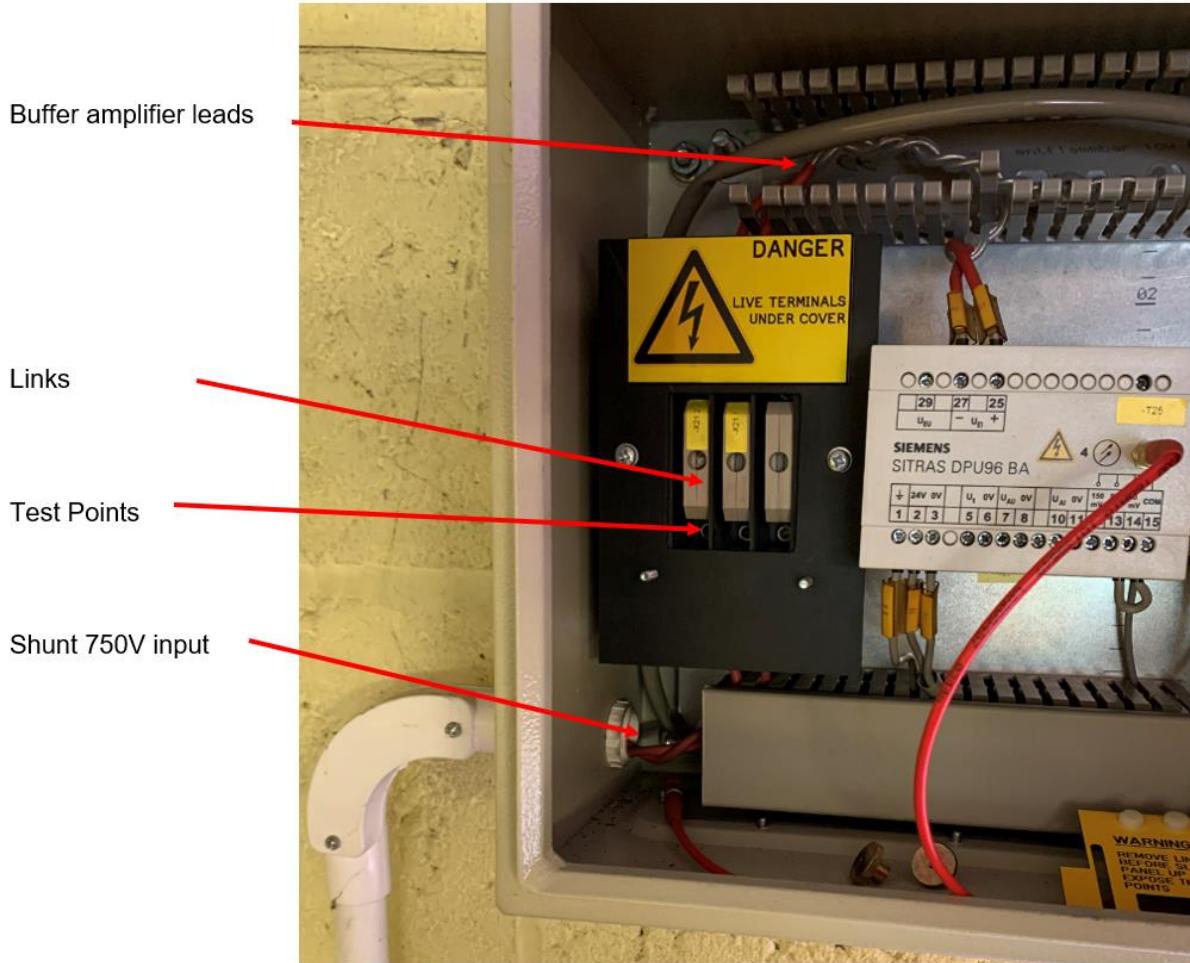
On investigation the shunt and buffer amplifier connections were found to be reversed on the test block. The modified schematic shows the arrangement as installed, with the test points connected directly to the shunt and the links disconnecting towards the buffer amplifier.

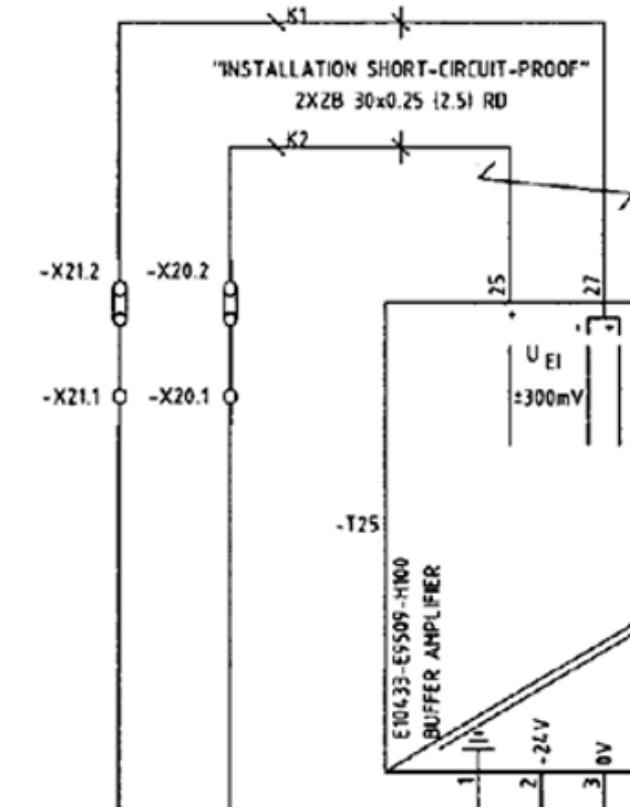
Wiring as installed on site

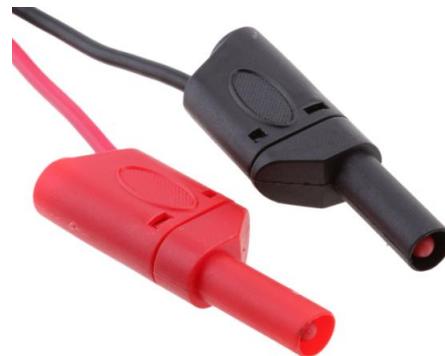
The leads being used were “open” and therefore unprotected. This caused to the flashover to earth when the lead came into contact with the switchboard. Staff are reminded to use shrouded leads when testing.
