Wessex Route

Welcome to your Health, Safety and Environment Cascade for Period 10 2016. This contains all the documents and safety briefs for you and your teams this period. Flick through this document and share as a team, print off the pages that you want to discuss and pin them up in mess rooms for staff to look at throughout the month.

Title: Slip and Fall in icy conditions in Eastleigh Depot Yard: Broken Arm.

Slip Whilst Removing Fishplate Bolts: Neck Injury

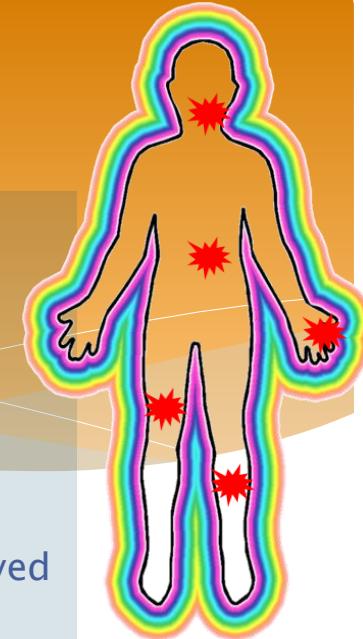
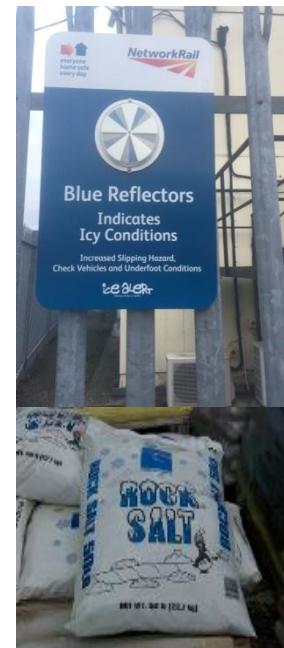
On 3rd January at 0740 hours, a member of staff working for Works Delivery Signalling Section slipped and fell over in exceptionally icy underfoot conditions. He sustained a nasty break to a bone in his right arm. (Humerous)

At the time he had walked out of the building and noticed a large patch of ice which he had placed a red fence around to warn others, he had then walked across the yard to the plant store to get salt to apply to the ice patch (The white salted area in the photo).

However before he could collect the rock salt to put on the ice, he walked back around the ice patch; it seems that he misjudged the slippery surface edge. He was wearing safety boots which were correctly fastened, but lost traction on the slippery surface; his feet went from underneath him. He put his hand and arm out to catch himself but as he came down he landed on his upper arm and shoulder, and he heard the crunch as his arm was damaged.

The front of the entrance of the Depot yard had been treated already but not the rest of the yard / compound where it had happened.

The area has been reported to Property Hotline as water is known to gather at this particular spot.

1. During these very cold weather conditions all areas of Depot yards must be regularly treated with Rock salt or similar anti-ice treatments.
2. Areas known for gathering water should be closely monitored whilst waiting for action and if Property Action does not respond in a timely manner escalate the complaint.
3. During icy conditions make sure we have sufficient rock salt or similar anti-ice treatments available and use liberally;
 - At the depot
 - On or near the vehicles
 - Access Gates and steps
 - Taken to site.
