# Rail Accident Report

**Near miss with a group of track workers at  
Egmanton level crossing, Nottinghamshire  
5 October 2017**

Report 11/2018  
August 2018

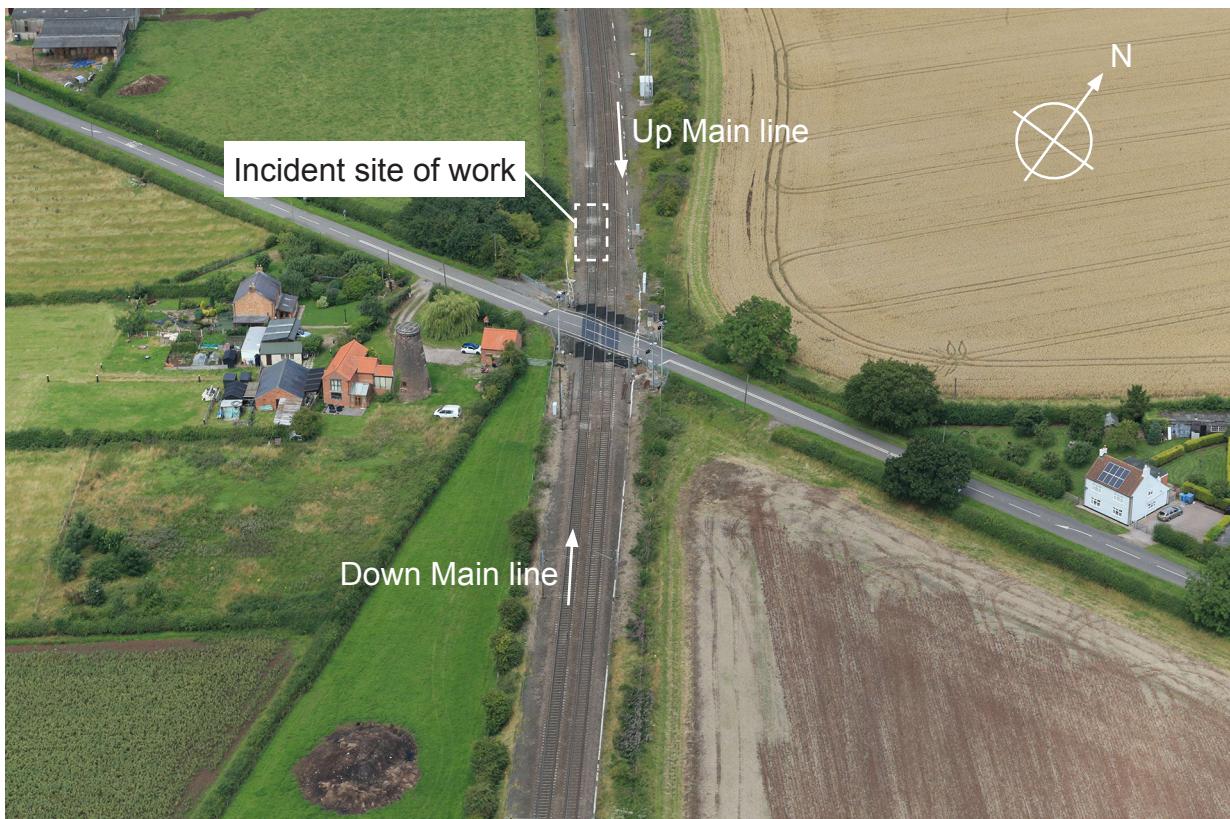
Figure 2: The track layout and the incident site of work near Egmanton level crossing (image courtesy of Network Rail)

- 8 The incident occurred around 30 metres north-west of Egmanton level crossing (figure 2) which is located on the East Coast Main Line (ECML) at 130 miles 29 chains from London Kings Cross. The location is between Newark North Gate station to the south, and Retford station to the north.

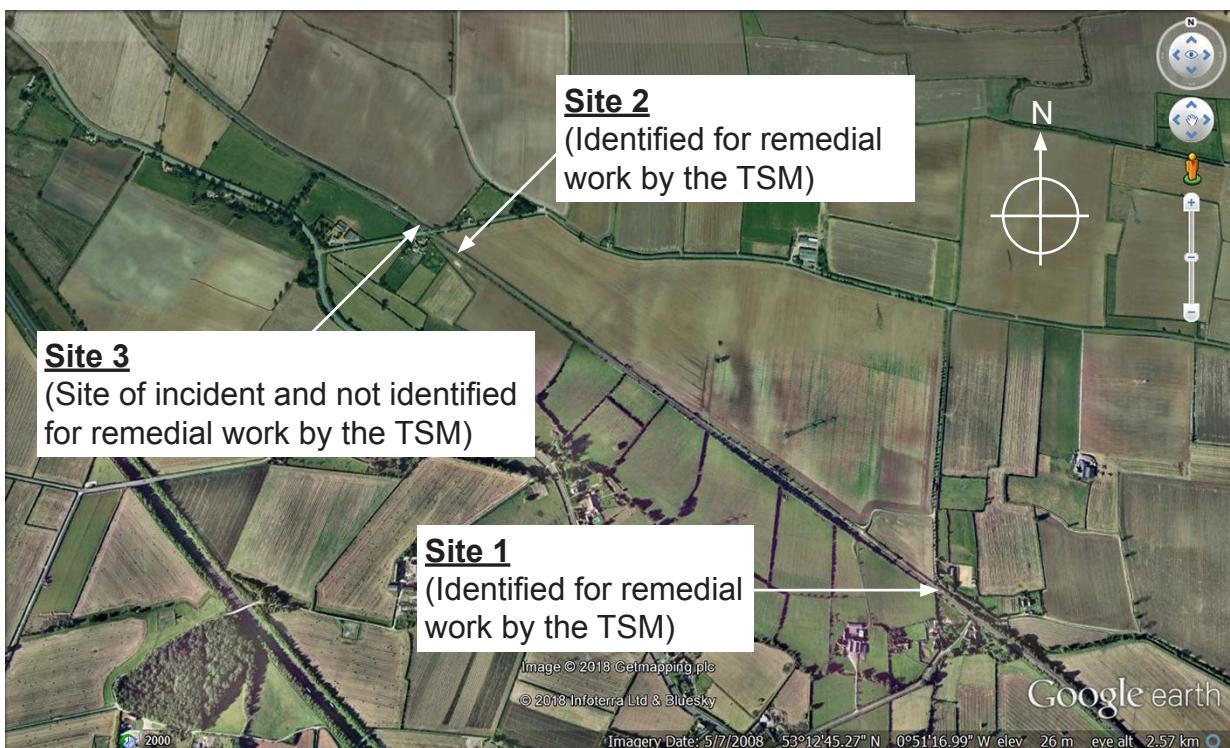
Figure 3: Locations of the three sites of work (image courtesy of Google Earth)

- 31 The first site of work covered by this SWP was approximately 1 mile (1.6 km) south of Egmanton level crossing and the second was around 20 metres south of the crossing (figure 3). The PiC and the planner, who was also familiar with the area, agreed that this plan could be used to cover both sites of work. The SWP covered a distance of approximately 2.75 miles (4.4 km), allowing the PiC to decide the most appropriate entry and exit points to the railway. The planner suggested that Egmanton level crossing be an access location to the second site of work, so this became the northerly limit stated on the SWP.

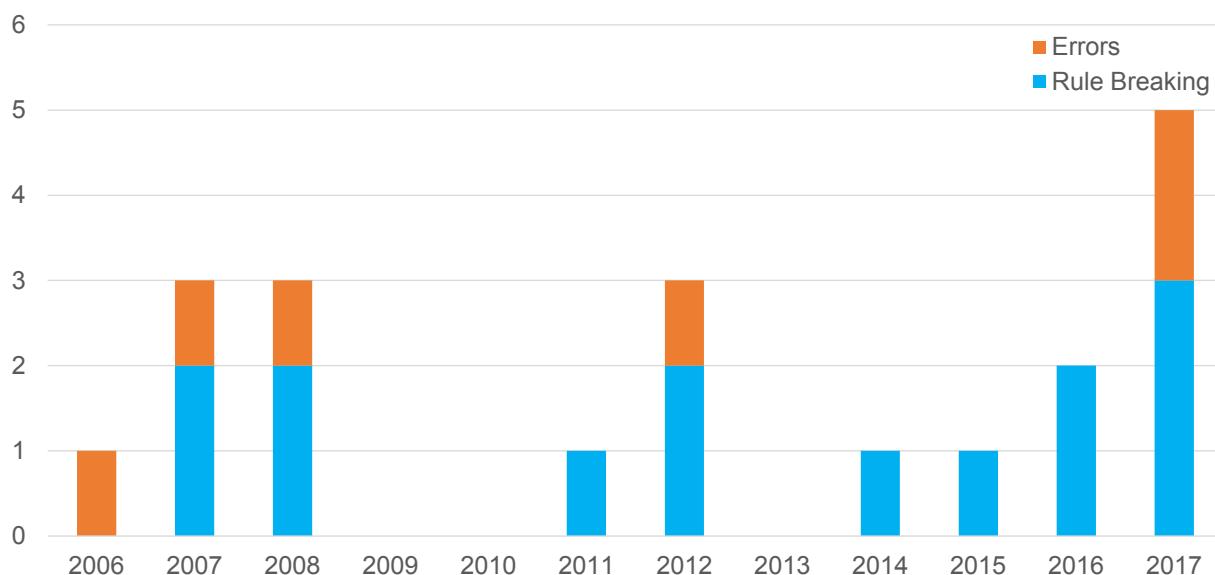
Figure 9: Stacked bar chart showing RAIB investigations into serious track worker incidents and accidents with moving trains, from 2006 to 2017 inclusive, where a causal factor was either an error, or rule breaking behaviour, by the COSS

113 Figure 9 shows the number of RAIB investigations into serious track worker incidents and accidents for every year since 2006. This suggests a persistent problem with track safety behaviours and leadership.
