# Rail Accident Report

**Fatal accident at Trenos footpath crossing near  
Llanharan, Rhondda Cynon Taf, South Wales,  
1 June 2017**

Report 07/2018  
May 2018

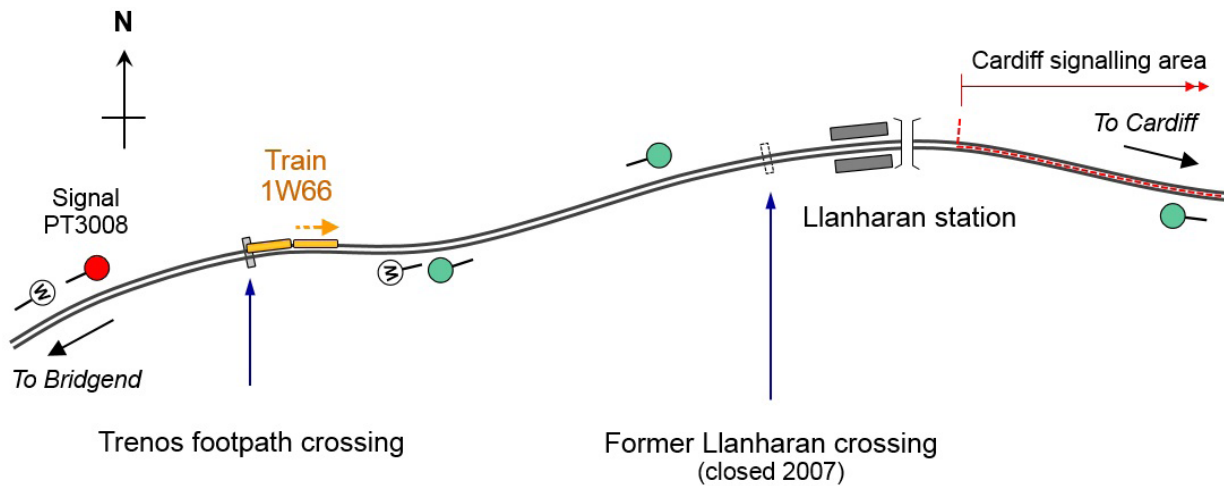
Figure 8: diagram at 15:32 hrs

- 27 The driver sounded the train's horn again, nine seconds before the crossing, and applied the brake. The on-train data recorder confirms that the driver did not use the train's emergency brake. At 15:32 hrs, the train stopped with its rear cab over the crossing (figure 8).

- 28 The driver looked out of the leading cab's right-hand window and saw the train's guard, who was travelling in the rear cab, speaking to the pedestrian. The guard believed the pedestrian was at immediate risk and shouted that she should get off the crossing. The driver then observed the pedestrian move off the crossing, and resumed the journey. He did not immediately report the incident despite the out of course stop. He attempted to contact the guard by the train's cab-to-cab telephone system, but this was not working.

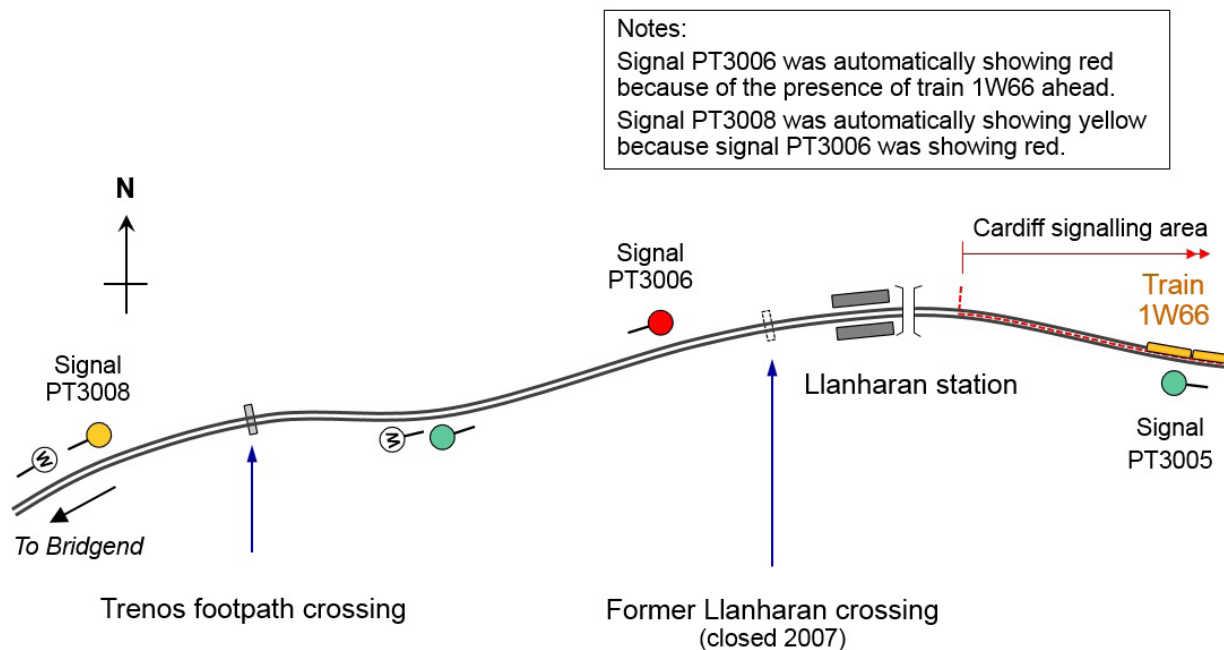
Figure 9: diagram at 15:35 hrs

- 29 The guard also used the train's cab-to-cab telephone but was unable to contact the driver. The guard ran through the 2-carriage train and entered the driver's cab. He informed the driver that he was concerned about the pedestrian's state of mind and advised the driver to report the incident to the signaller. The driver applied the brake and stopped the train for a second time east of Llanharan station at 15:35 hrs (figure 9).

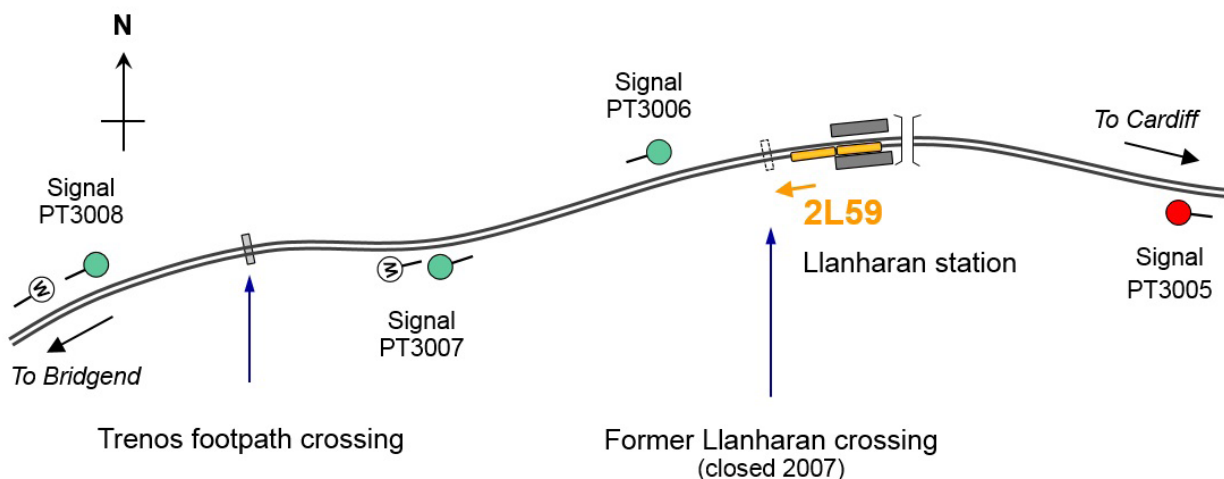
Figure 11: diagram at 15:48 hrs

- 38 At 15:48 hrs (figure 11), train 2L59 departed from its booked stop at Llanharan station and accelerated towards its next stop at Pencoed station. This service was due to depart Llanharan at 15:36 hrs, but had been delayed at Cardiff and was running about 12 minutes late.
