IMDM OUTER

Title: DC Electrical Flash-over: Apprentice Arc Eye.

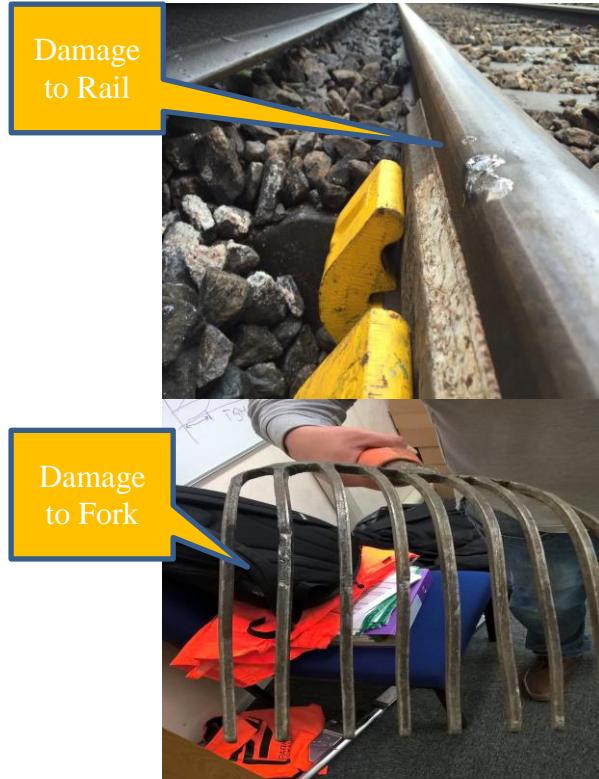
On 9th November 2016 at 0938 hrs on the Down Brighton at 36m 32ch (Havant) an NR Apprentice sustained a minor arc eye injury during an electrical flash-over event, when the metal prong of an approved and insulated fork came into contact with both a running rail and a live 750v d.c. conductor rail simultaneously.

The team were tasked with measured shovel packing. Whilst replenishing ballast in bays to fill empty beds between a running rail and live conductor rail one of the Apprentices had moved outside of the protection area provided by a conductor rail shield and inadvertently put the fork he was using between the two rails causing contact and the flash-over.

The injured Person was one of two Apprentices on attachment from the IP High Output Track Renewals to a Permanent Way Section. He was lent over adjacent to his colleague when the flash-over occurred. He suffered temporary blindness for 10 minutes, visited hospital and was discharged without further concern.

1. Always have sufficient conductor rail shields on site and placed over the conductor rail to cover the work area.
2. Check everyone understands the limits of this work area.
3. All 'inexperienced' members of staff on a NETOPS worksite are subject to the New Starters Mentoring (Safety Passport scheme).
4. The Team Leader (this may be the COSS) shall appoint an experienced person as a Minder/ Buddy to accompany every passport holder at all times whilst lineside.
