**Works Delivery**  
**Title: Two injuries whilst lowering running rails using Jacks.**

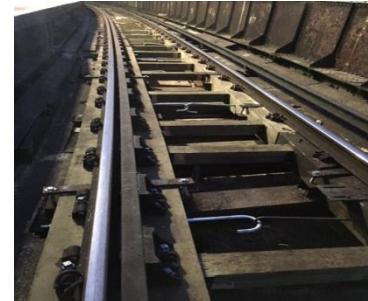
On 11 January 2017 at 0650 hrs on the WPH2 between Fratton and Portsmouth Harbour, a member of staff suffered a foot injury.

A length of running rail was raised on rail jacks. When it was released from the rail jack; the IP was holding a heel bar within the 'drop zone'. The rail stuck the bar; the bar was forced out of his hand, falling to the ground with some force, striking the top of his foot behind the steel toe cap causing bruising to his toes.

When lowering rails on jacks:

1. A clear line of communication must be established under one nominated person.
2. Prior to the drop, the nominated person gives clear instructions to 'clear',
3. All others remove tools and body parts in vicinity of drop zone and confirm back that tools and body parts are 'clear'
4. The instruction is given to lower rail.

***No parts of the body should ever be present under suspended loads.***

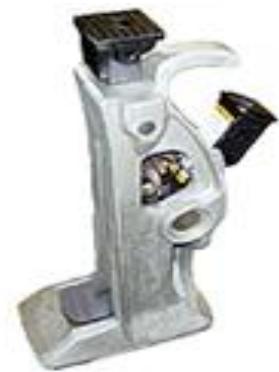
On 19 February 2017 at 10:00 hrs at Millbrook on the BML2 between Southampton and Redbridge, a member of staff suffered an injury to his hand.

A team were changing sleepers, the running rail had been jacked up by a simplex jack; the IP was in the process of clearing out ballast from underneath the base plate of the rail, when another operative released the jack without prior warning. The IP's right hand became trapped by the baseplate, his hand immediately became swollen, but no bones were broken.
