TEMPLATE FOR BRIEFING OF SERIOUS OPERATIONAL INCIDENTS

Immediately Transferable Lessons from level crossing incidents

Information for Signallers and Front Line Operational Staff

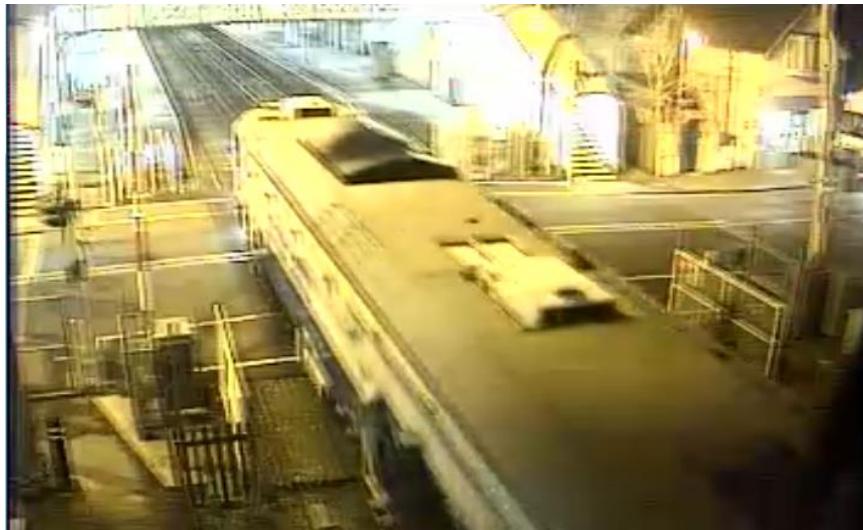
On Thursday 9th March, at approximately 04:14, the Signaller operating panel 1 at Feltham ASC authorised the driver of 6J61 to exit an engineer's possession after confirmation that the detonator protection had been lifted. A route card was required for the movement as there were two sets of points and a CCTV level crossing within the route that 6J61 needed to traverse. The Signaller forgot to lower the barriers at Strawberry Hill level crossing and as a result 6J61 traversed the crossing with all barriers in the fully raised position. The driver of 6J61 observed the barriers were not lowered, stopped his train after passing the crossing and reported the incident to the Signaller. Fortunately no members of the public were inside the crossing limits when the incident took place.

Reason Incident Occurred:

- The Signaller failed to correctly follow the route card instructions, which included lowering the level crossing barriers and placing the auto raise switch into the manual position.
- The Signaller failed to ensure that the portion of line concerned was clear and safe for the movement as per rule book module S5.
