Works Delivery
Title: Two injuries whilst lowering running rails using Jacks.

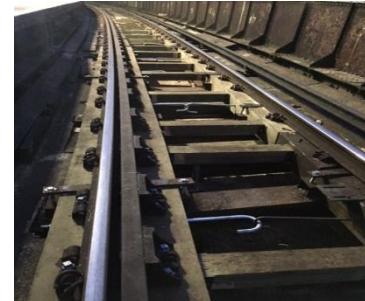
Incident 1

On 11 January 2017 at 0650 hrs on the WPH2 between Fratton and Portsmouth Harbour, a member of staff suffered a foot injury.

A length of running rail was raised on rail jacks. When it was released from the rail jack; the IP was holding a heel bar within the 'drop zone'. The rail stuck the bar; the bar was forced out of his hand, falling to the ground with some force, striking the top of his foot behind the steel toe cap causing bruising to his toes.

When lowering rails on jacks:

1. A clear line of communication must be established under one nominated person.
2. Prior to the drop, the nominated person gives clear instructions to 'clear',
3. All others remove tools and body parts in vicinity of drop zone and confirm back that tools and body parts are 'clear'
4. The instruction is given to lower rail.

No parts of the body should ever be present under suspended loads.

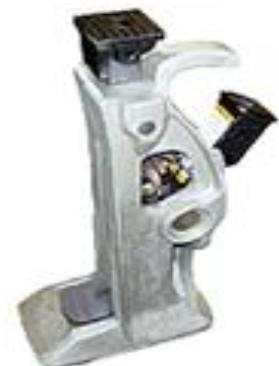
Incident 2

On 19 February 2017 at 10:00 hrs at Millbrook on the BML2 between Southampton and Redbridge, a member of staff suffered an injury to his hand.

A team were changing sleepers, the running rail had been jacked up by a simplex jack; the IP was in the process of clearing out ballast from underneath the base plate of the rail, when another operative released the jack without prior warning. The IP's right hand became trapped by the baseplate, his hand immediately became swollen, but no bones were broken.
