SCRAP RAIL, SHORT LENGTHS (THE VANDALISM RISK).

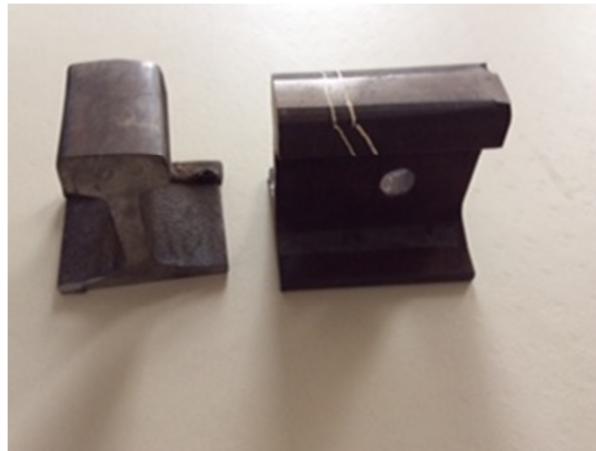
The above sections of scrap rail are 12cms (4.8inches) and 16cms (6.4 inches) long, respectively.

To remove the risk of vandalism, we are asking YOU to locate, log and if safe to do so, REMOVE small (anything up to 30cm) pieces of scrap rail away from the track.

If you encounter small pieces of rail that you cannot remove, but could pose a risk (either from vandalism or as a slip, trip and fall hazard), report it for future removal.

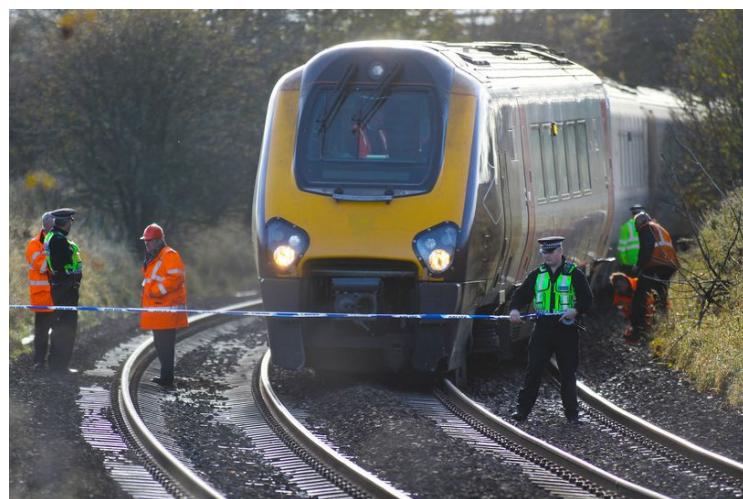
Cast your mind back to the last major incident which resulted in a train derailment, Inverkeilor, Scotland, 4th November 2012

As the Edinburgh to Aberdeen train passed over the trailing points from the down sidings at close to the line speed of 80 mph, the left-hand front wheel struck a 60cm section of rail that had been deliberately placed on the track by trespassers as an obstruction in the crossing. This resulted in the front of the train rising up, with the leading bogie derailing into the six-foot.
