IMDM OUTER**Title: Staff Accident; Rail turned onto an employee's foot****Injury: Broken Metatarsals****Incident**

IMDM Outer. Staff Accident Rail turned onto an employee's foot**Issue Date: 08/04/2019**

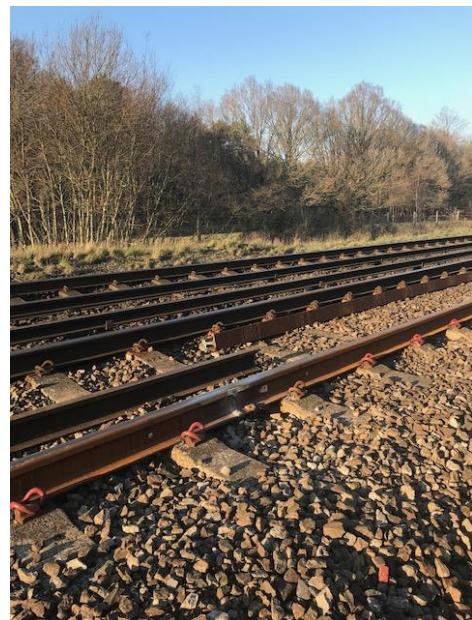
On the 27th of March 2019 at 01:15hrs hours, a P/Way team member based at Bournemouth Maintenance depot was working at Woodfidey LC (Beaulieu Road) where he sustained an injury from a rail being turned whilst standing in the 4 foot.

This was caused when a member of the GPX Welders team moved a piece of scrap rail in the 4 foot.

When the member of the Welding team moved the rail, he failed to check that everyone was clear, nor did he give a warning call informing those around him what he was about to do.

Subsequently the rail was turned on its side trapping the member of staffs' right foot.

It was confirmed that he had sustained broken second and third metatarsal on his right foot. The IP was fitted with a boot and then returned home, hospital staff have advised heal time is approximately 2 months.

- The importance of remaining vigilant at all times and the importance of warning others in your work site when moving rails
- Any team manual handling should be properly co-ordinated and the person in charge should control all the movements
- Remember to report any defects that may affect the safety of the line or safety of others using that specific area of the infrastructure through the WICC
