IMDM INNER

Title: S&T Location Case Barrier accident - 27th May 2019 (03:15)

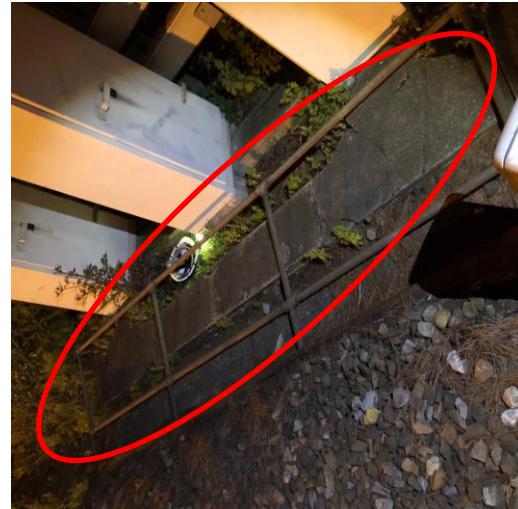
The team began working within WD21 Location Case and an Operative who was part of the team (in the role of Site Warden) lent against the barrier, which is positioned in front of the Location Case and functions to prevent the inadvertent access to either the operational railway or the electrified third rail.

The barrier, which broke away at its base, gave way under the Operative, causing him to fall to the ground and resulting in him landing on his right forearm and suffering some pain to his lower back.

Above: The barrier and Operatives hard hat (circled) following the accident, with Loc cases behind.

- Do NOT lean against Location Case barriers. They are there to prevent inadvertent access to the operational railway and/or the electrified third rail!
- The same practice (leaning against a Loc barrier) was observed just one day after this accident, by a member of the Wessex Safety Team.
- EL21 Section 1.4 of NR/L3/SIG/10663 **SIGNAL MAINTENANCE SPECIFICATIONS** states that; as part of the external inspection, staff should check (if provided) that any guarding or staging are secure.
- Where an accident/incident has occurred, do as the S&T team did here and leave the location as safe as possible for the next team on site.
