IMDM INNER – Church Lane, Haslemere, WPH1

Title: Off-Track Impact Accident Injury: Dislocated Finger

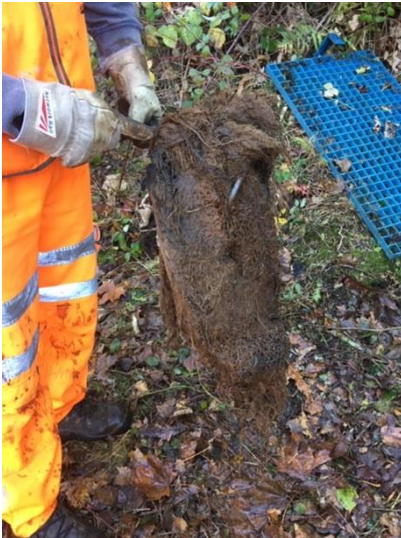
Roots removed using the 'Pigs Tail'

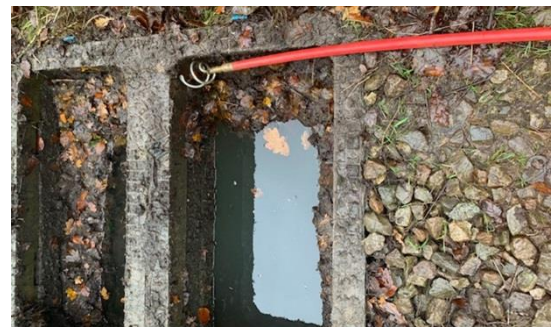
A cork-screw or 'pigs-tail' was fixed to the first rod; this is a helically shaped attachment used to ensnare roots so they can be pulled free, releasing the system. Feeding this into the pipes, sections of rods were added until the blockage was reached and then a handle was attached allowing the rods to be turned with force. The IP began to wind the handle with his right hand supporting the rods with his left. Experiencing resistance, he attempted to use his strength to tear through the obstruction however the blockage did not yield and the torque built-up until the handle slipped from his hand, springing back, striking the IP and dislocating his left index finger in the process. Due to the nature of the injury no first aid was given. The IP was taken directly to hospital where he had his finger re-set.

'Pigs Tail' fixed to drainage rods resting on a catch-pit

1. **TAKE FIVE FOR SAFETY** – could the team have thought of a better way to complete their work, or to assess what they were up against, such as a drain survey?
2. Encountering resistance, the IP attempted to force his way through using brute strength and tension built up in the rods rapidly. Would a slower, considered approach have allowed him to more accurately assess the situation as it progressed?
3. In this instance the right gloves were being worn however conditions were poor and they had been used for work prior to this task. Were the gloves wet or compromised with a contaminant such as mud or grease that may have reduced their effectiveness gripping the rods, causing them to slip?
4. First aid – In this case no first aid was applied, and this was the correct decision; resetting a dislocated appendage must only ever be attempted by a trained medical professional.
